# Soils and Vegetation of the Trans-Alaska Pipeline Route: A 1999 Survey

Bulletin 109

January 2002

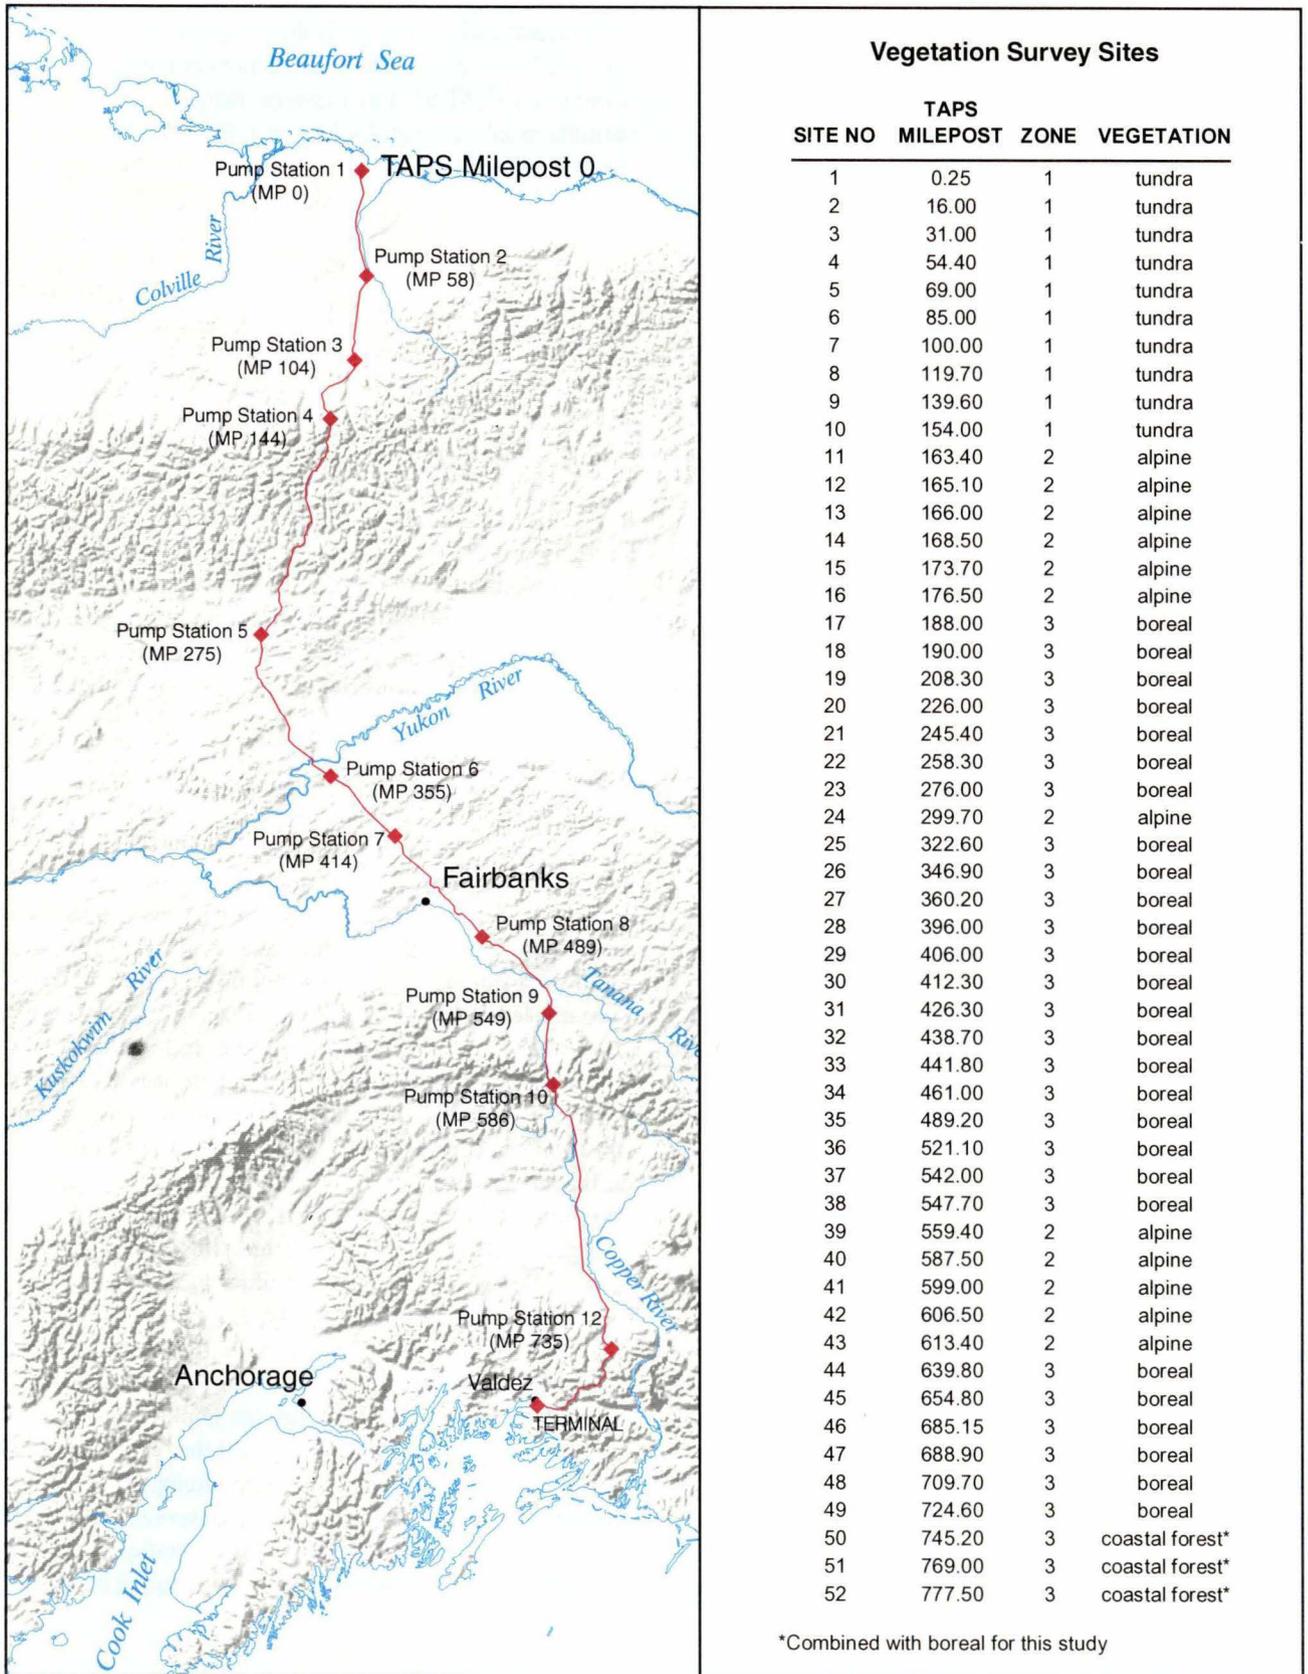
Figure 1. TAPS route map with vegetation survey site locations.

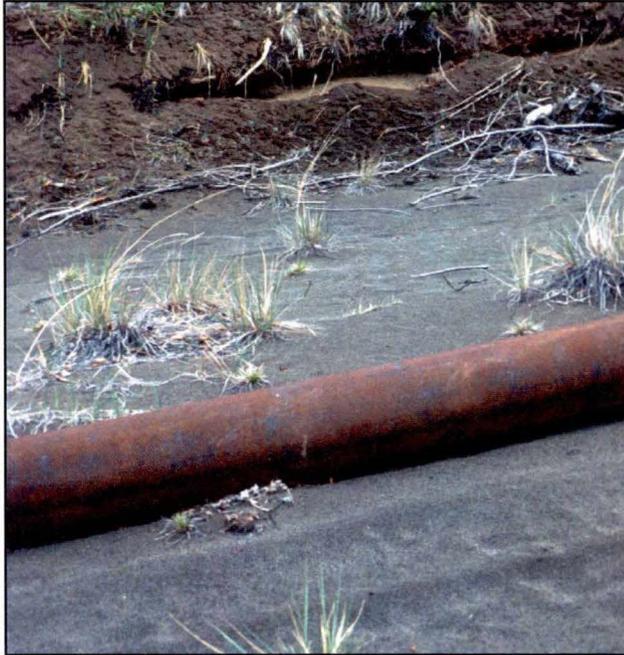
*Photo 1. View of Haines pipeline right-of-way, 4 June 1978, showing poorly vegetated dry sand 22 to 23 years after construction. The silt layer that originally covered the entire site is visible in the background. Limited plant growth (*Calamagrostis purpurascens*) on the sand in the foreground illustrates the importance of soil fines (silt and clay) for supporting vegetation.*

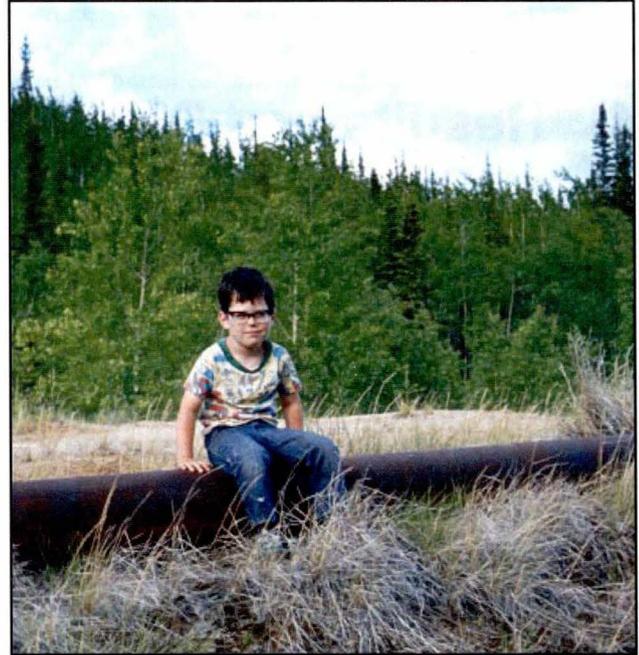
*Photo 2. View of mesic, silty soil site along Haines pipeline, 8 June 1978, 22 to 23 years after construction. Soil at this site consists of a thin layer of silt over sand. *Calamagrostis purpurascens* is the dominant plant that naturally recolonized at this location, in contrast with the previous photo, where very little grass established. No artificial revegetation was practiced on this right-of-way.*

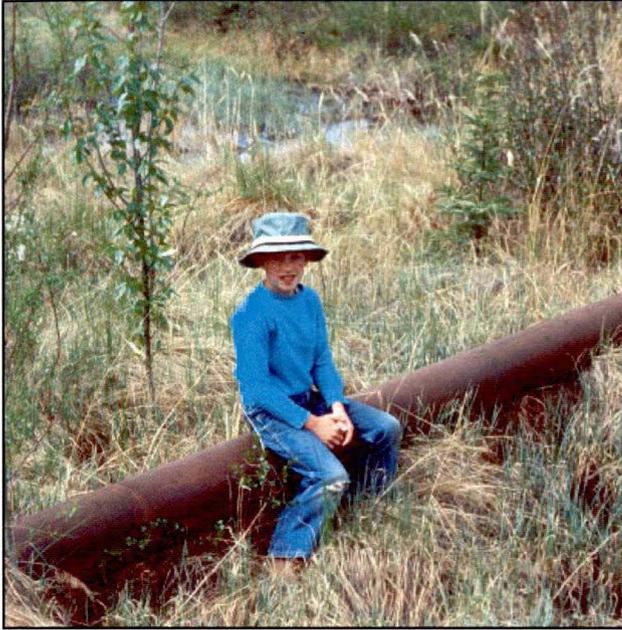
Photo 3. View of well vegetated wetland site within the Haines pipeline right-of-way, 9 June 1977, 21 to 22 years following construction. Grass, willow, cottonwood, spruce, and sedge have naturally recolonized at this location. Comparing vegetation in this habitat to those in the previous two photos shows that, with adequate soil moisture and nutrients, natural recolonization in Alaska's boreal zone is sufficiently robust to provide adequate soil cover within 20 years. This pipeline route was neither seeded nor fertilized following construction. Herbicides were used to control brush and trees during the operational life of this pipeline. Woody species in this image invaded after chemical control was discontinued.

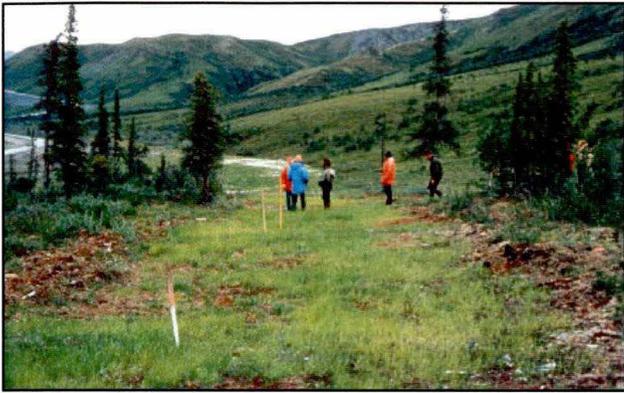
Photo 4. An ice road was constructed at this location at the base of the Chandalar Shelf (N68° 01' 46.3"; W149° 40' 56.7") to move supplies to the North Slope before the Dalton Highway was constructed. After the ice road route was no longer needed, the clearing was seeded to annual ryegrass (*Lolium multiflorum*) and fertilized. In this view (27 July 1975), the ryegrass is growing in the clearing.

One of the most striking features of vegetation in the boreal vegetation zone has been the invasion of the TAPS ROW by trees and shrubs. The process began subtly and produced only minor aspect changes for perhaps ten or more years. However in the last ten years, this woody plant growth has become a major factor in the ROW. The accompanying series of photos taken in the upper Dietrich River valley illustrate that process (Photos 4, 5, 6).

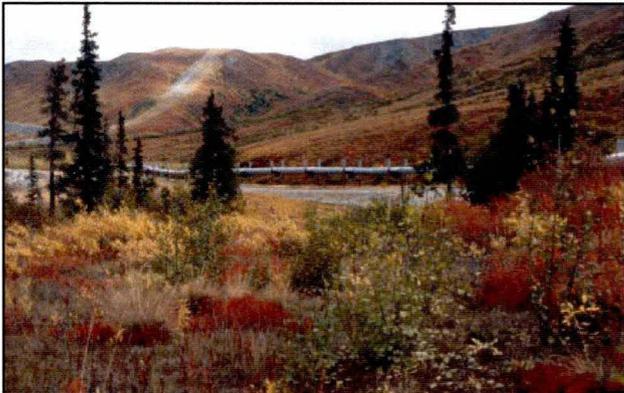
Photo 5. A view of the same site shown in Photo 4. In this image (31 August 1985), the trans-Alaska pipeline can be seen in the background. The clearing that was created for the ice road has been invaded by indigenous plant species, including alder and bluejoint reedgrass. The annual grass has long since died.

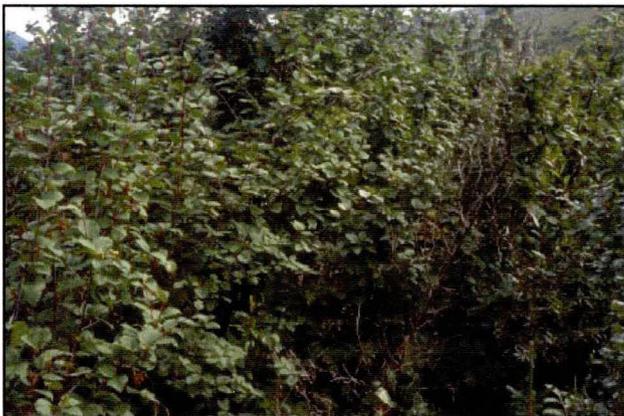
Photo 6. The same view of the ice road clearing as shown in Photos 4 and 5. In this view (22 July 1999), alder are the dominant vegetation in the clearing. Spruce trees are 3 to 4 feet in height beneath the alder. Blueberry shrubs are common in the former clearing, as are willow and other woody species.

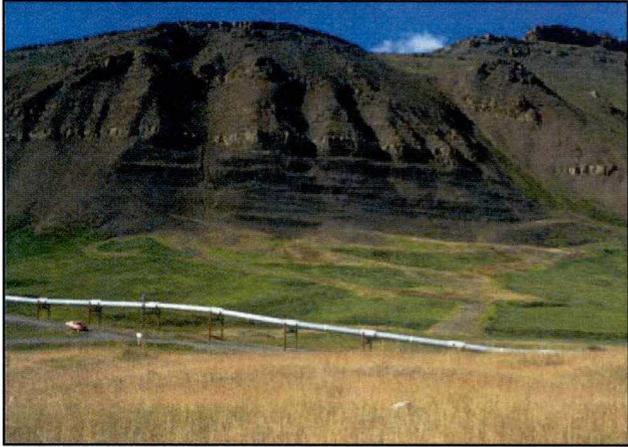
Photo 7. Material site at base of Slope Mountain and seeded grass in the foreground. Even though most of the Slope Mountain material site has little soil cover, vegetation has established in several habitats at this location.

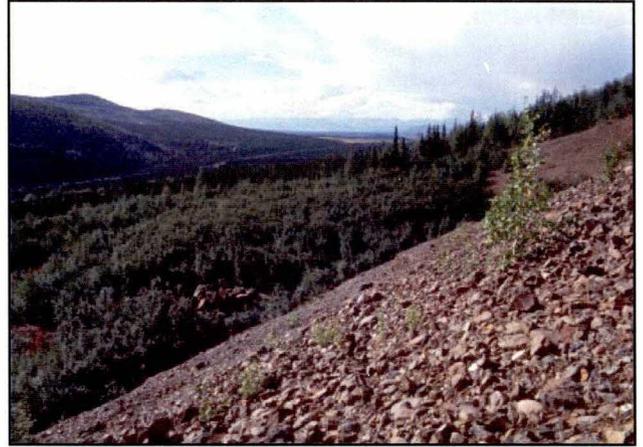
Photo 9. View of material site (23 July 1997) recolonized in 20 years predominantly by shrubs and trees. This location (N 66 21' 31"; W 150 27' 32") is approximately 2 miles south of the crossing of the South Fork of the Koyukuk River. Soil was replaced in the basin, and it was seeded to grasses. Species of seeded grasses persisting in openings beneath the canopy include: *Bromus inermis*, *Alopecurus pratensis*, and *Festuca rubra*. Other plants which had colonized naturally were: willows, cottonwood, alder, spruce, birch, fireweed, moss, lichens, and the common weed, dandelion. The rocky slope in the foreground has siberian aster, *Antennaria rosea*, *Artemisia tilesii*, aspen, and birch colonizing among the stones.

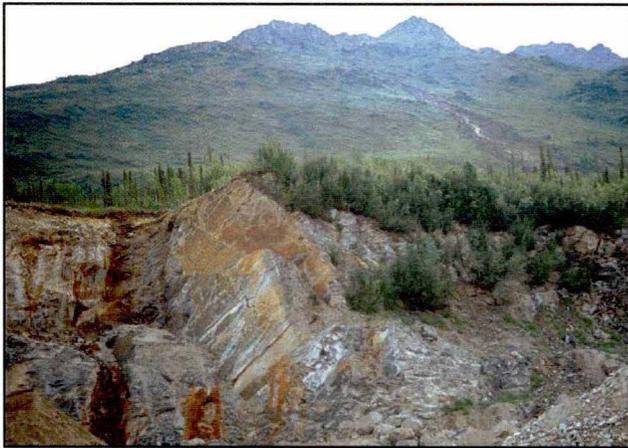
Photo 8. Rock quarry photographed 6 July 1996 (N67° 23' 54"; W150° 05' 16") near Wiseman, AK. On the left side of the image, stones have been recently removed. On the right side, alder and lower growing plants have colonized the surface of this material site during the approximately 20 years since the site was used for TAPS construction. This illustrates the ability of indigenous plants to colonize stony material sites in the boreal zone. In the background, a large barren gash appears on the mountain slope. This resulted from a recent natural landslide, illustrating that the presence of vegetation cover is no guarantee against powerful natural erosion forces.

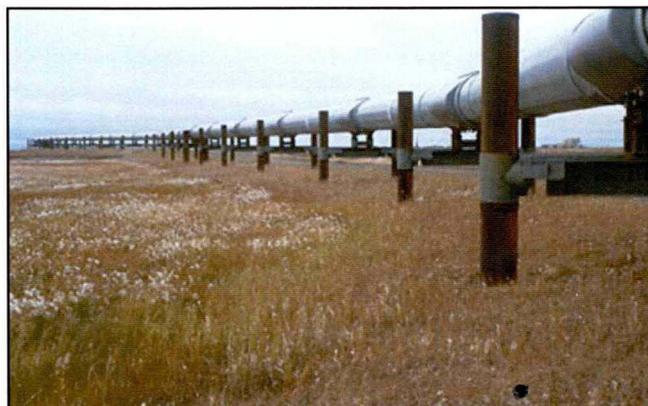
Photo 1-1. Southward along east side of elevated pipeline over drained lake basin at Pump Station 1. Gravel fill placed in the ROW is largely vegetated with seeded grasses, except in the wheel tracks of the road. The plants to the left established naturally in the lake basin.

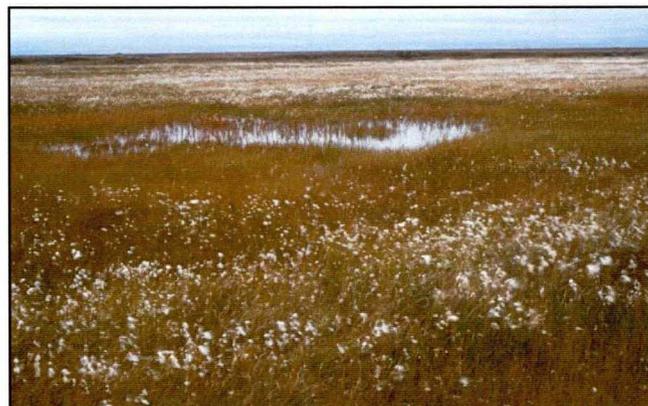
Photo 2-2. Northwest from ROW across lake basin drained to construct Pump Station 1. This portion has been naturally vegetated with *Eriophorum angustifolium*, *Dupontia fisheri*, and *Arctophila fulva*.

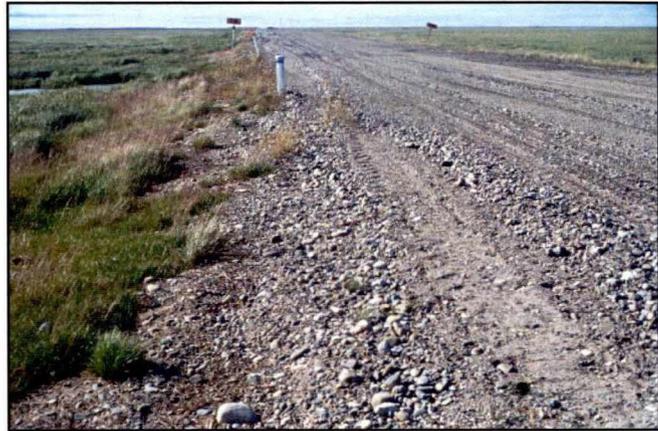
Photo 2-1. Southward along east side of buried pipe. This site has been recently worked upon, leaving barren gravel fill. The edge of the ROW that was undisturbed is supporting seeded and indigenous grasses.

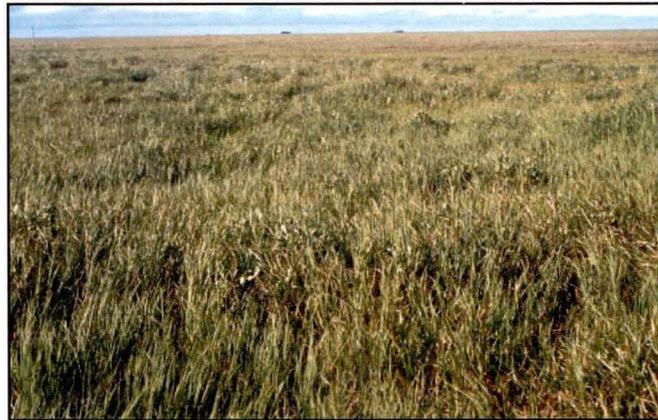
Photo 2-2. Wet sedge tundra on west side of ROW.

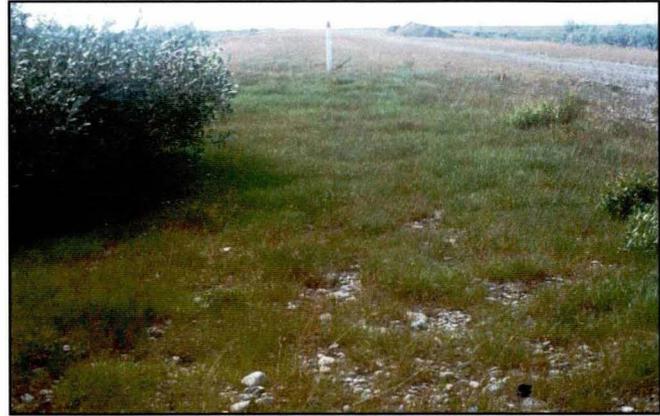
Photo 3-1. Southward view along buried section of pipeline near Franklin Bluffs. Seeded grasses dominate center, and tall willows line the margin.

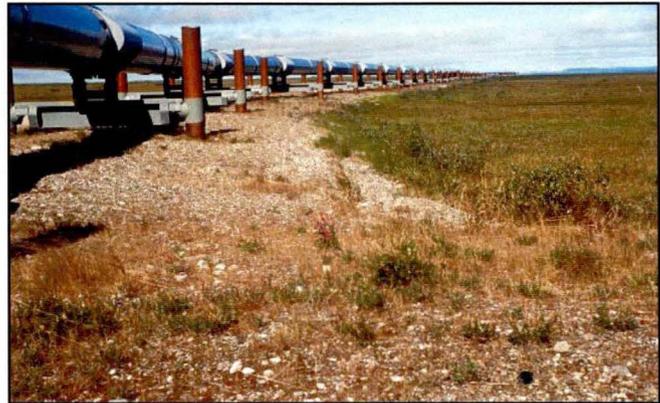
Photo 4-1. Northward along elevated pipe over gravel fill with sparse cover grasses, forbs, and shrubs.

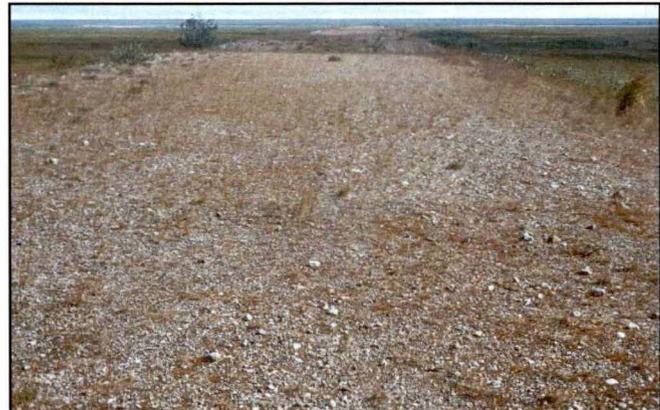
Photo 4-2. View east of abandoned gravel road between ROW and Sagavanirktok River. *Festuca rubra* seeded to vegetate the gravel fill dominates this habitat.

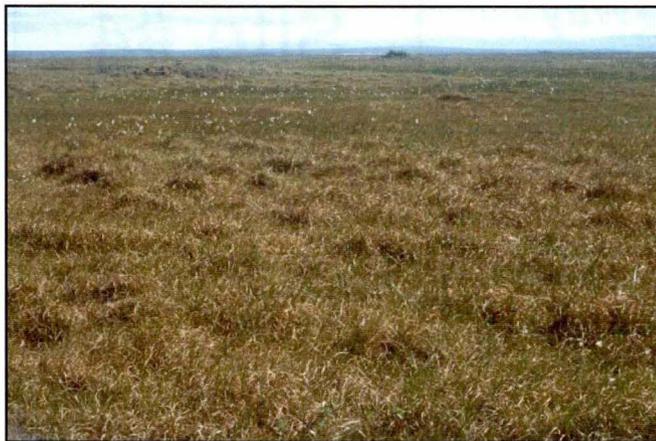
Photo 4-3. SE toward Brooks Range across sedge meadow next to ROW.

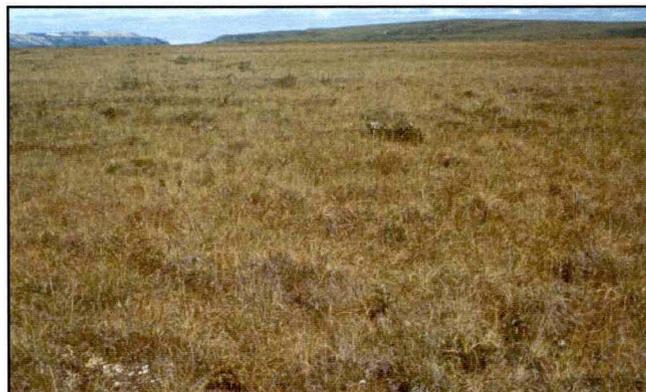
Photo 5-2. North across moist sedge-shrub tundra.

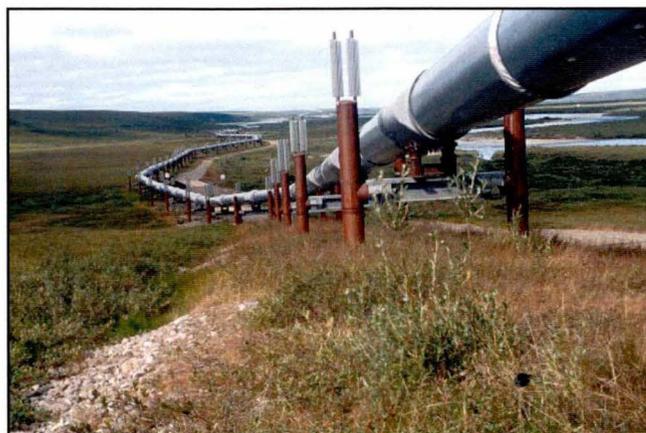
Photo 6-1. North along elevated pipe. Gravel fill within ROW is dominated by seeded grasses and shrubs, *Salix* and *Shepherdia*.

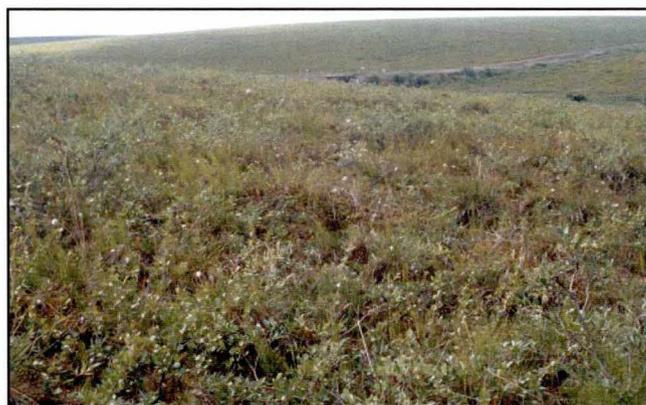
Photo 6-2. Northwest across adjacent tussock-shrub moist tundra.

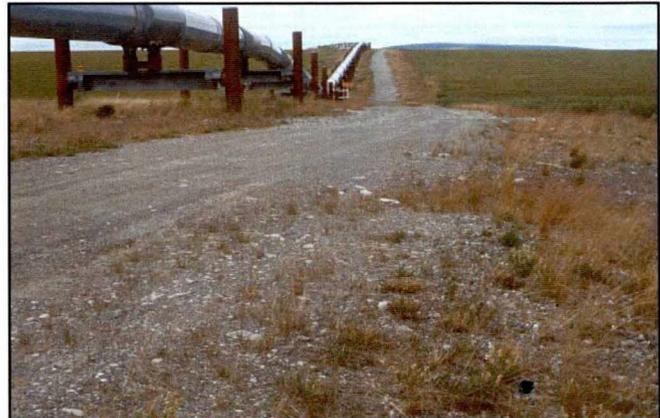
Photo 7-1. North along elevated pipeline. Gravel fill within ROW is well vegetated, except in roadway. Seeded grass and indigenous forbs predominate.

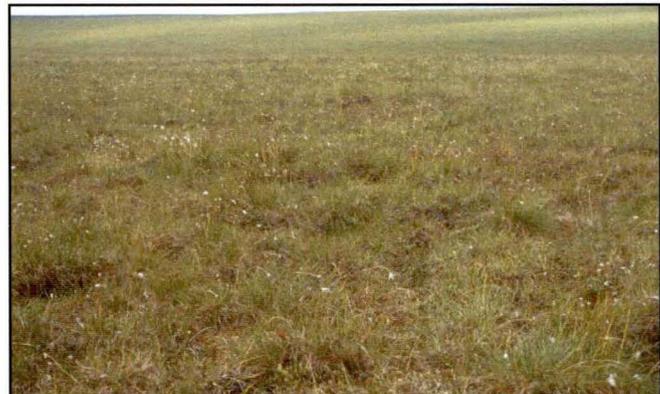
Photo 7-2. Adjacent moist tussock tundra.

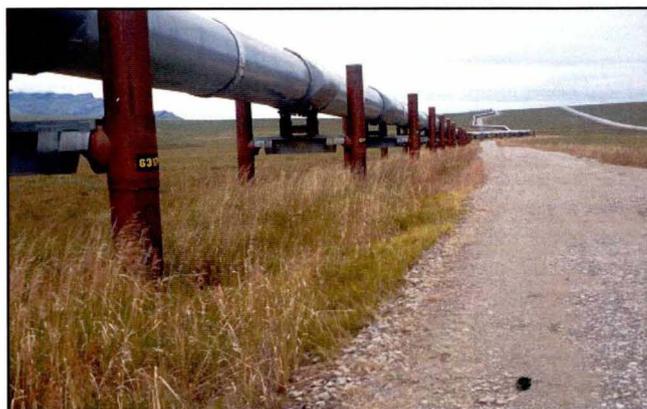
Photo 8-1. North along elevated pipe. This pipeline section was constructed from an ice road, and beneath the pipe, seeded *Arctagrostis latifolia* and *Equisetum arvense* predominate. Gravel fill of roadway is largely barren.

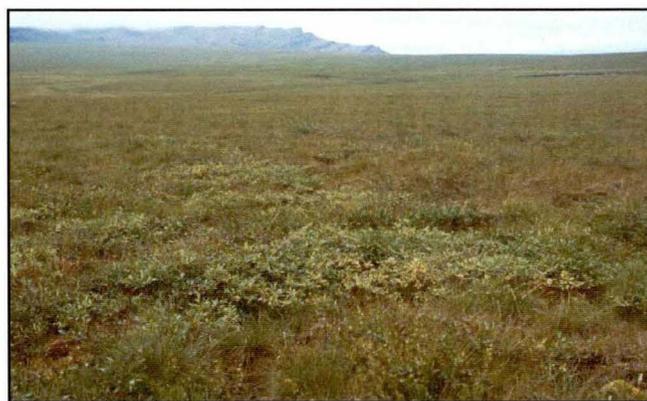
Photo 8-2. Northward across adjacent low shrub tussock tundra.

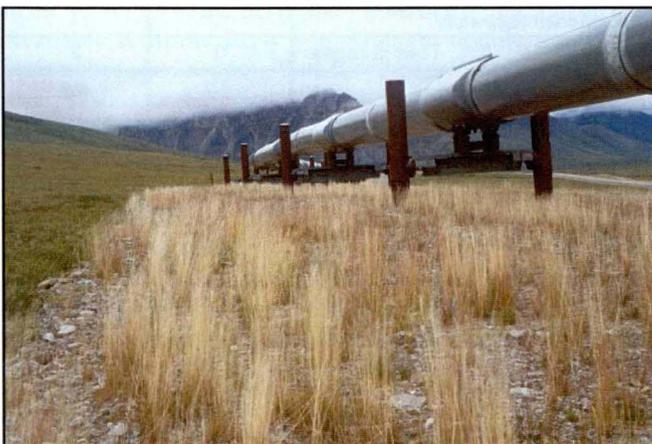
Photo 9-1. South along elevated pipe. Rocky fill at this site is dominated by naturally-established *Agropyron* spp. and seeded *Festuca rubra*.

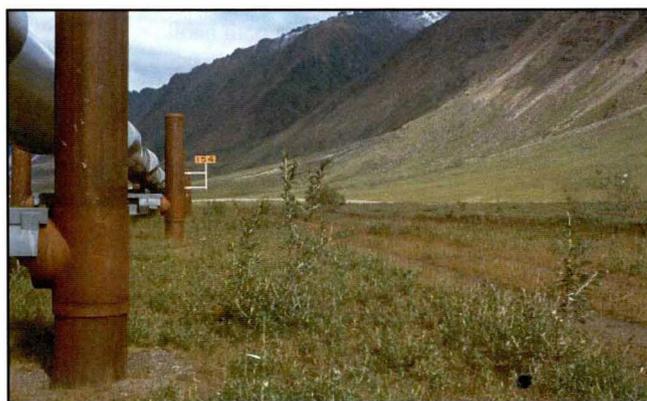
Photo 10-1. Southward along east side of elevated pipe in Atigun Canyon. ROW is being recolonized with indigenous plants, *Salix lanata* var. *richardsonii* being one of the most prominent. Seeded grasses line the wheel tracks in the roadway.

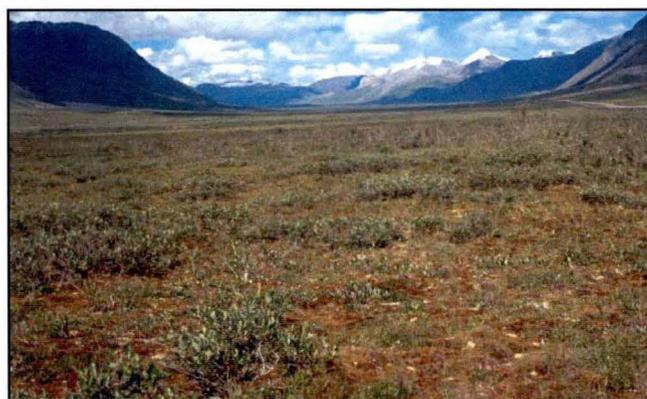
Photo 10-2. Mixture of low and tall shrub tundra west of the ROW.

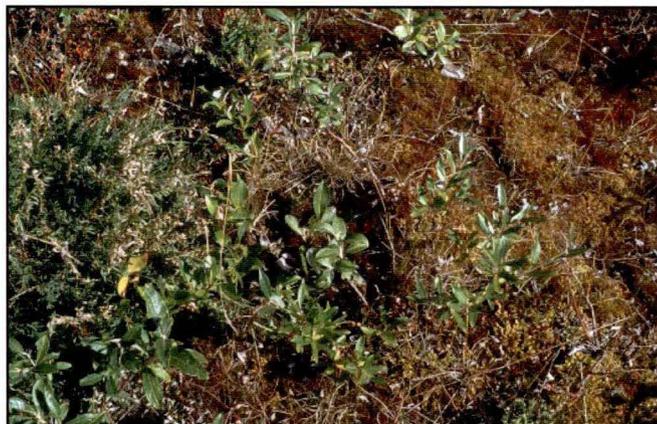
Photo 10-3. Example of short willow growth in adjacent shrub tundra.

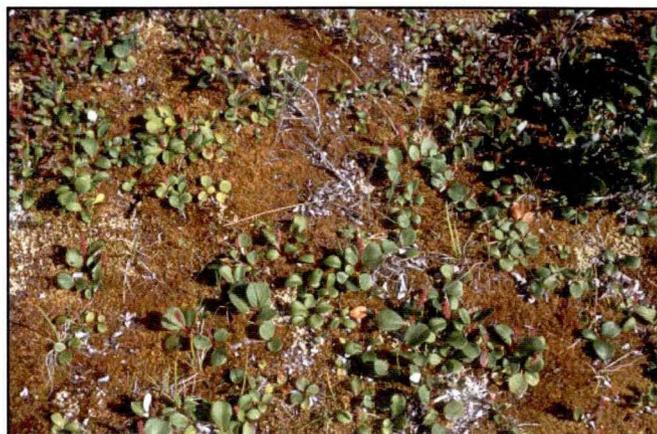
Photo 10-4. Moss and mat willows in adjacent shrub tundra.

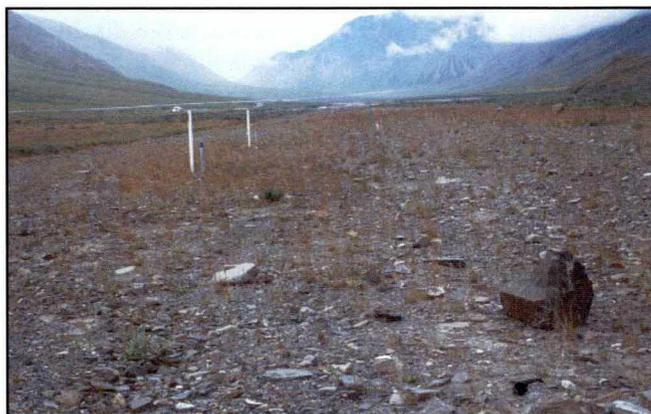
Photo 11-1. Southward across buried pipeline in upper Atigun Canyon. Disturbed stream channel gravel is sparsely covered by seeded grasses and naturally-established forbs and shrubs.

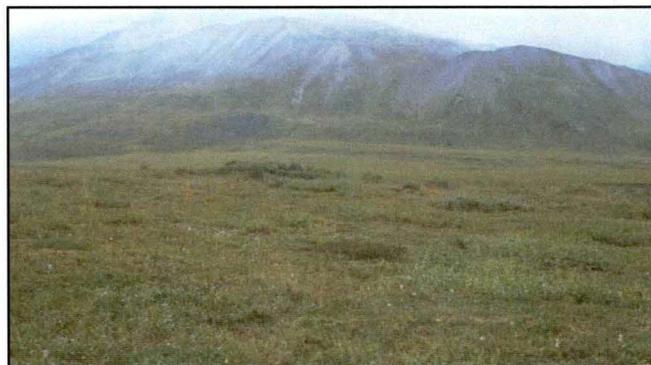
Photo 11-2. Complex of mat plant growth alpine tundra west of ROW. This community is growing on a geologically older surface than that of the ROW before construction.

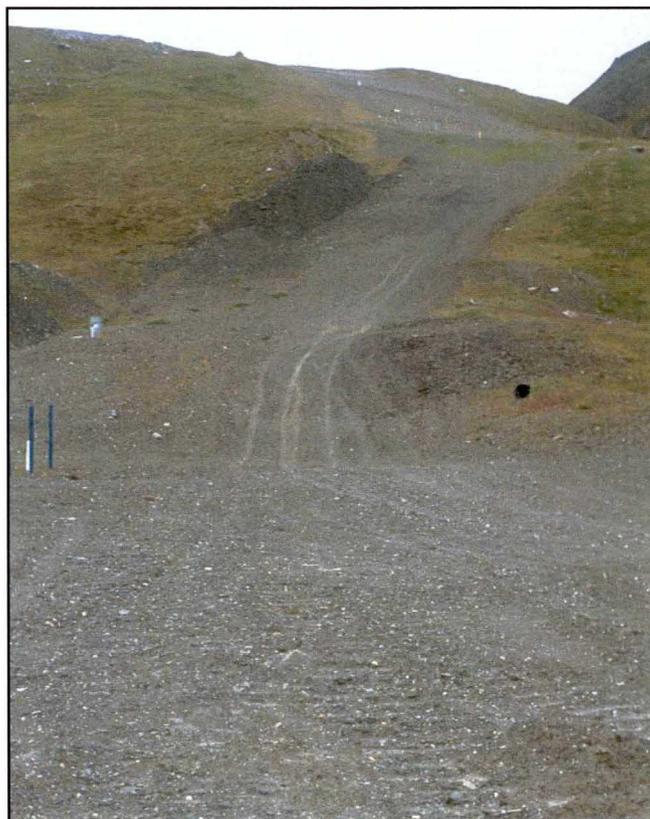
Photo 12-1. Westward view of buried pipeline, north base of Atigun Pass. Barren gravel predominates. The site was disturbed by maintenance after an oil spill. With more fines, the substrate could support vegetation.

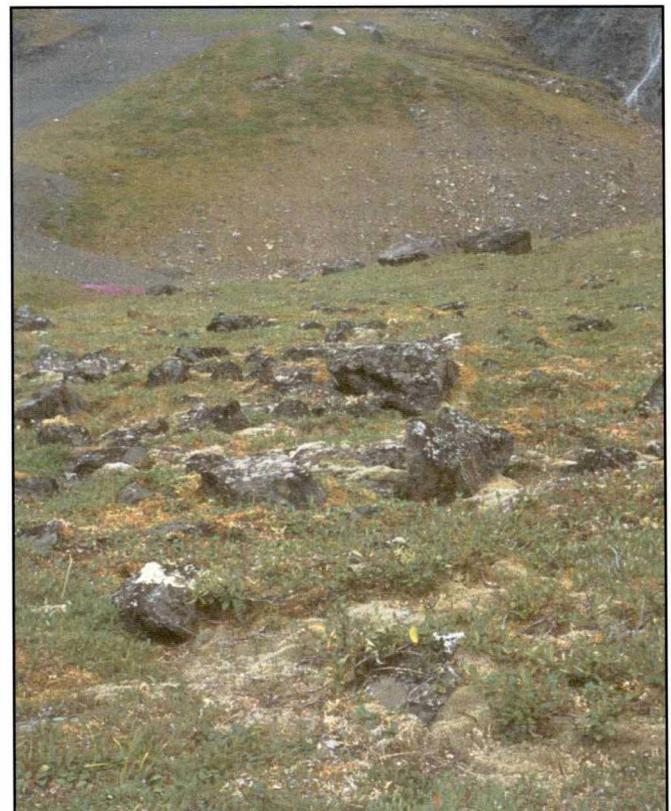
Photo 12-2. Undisturbed alpine vegetation consisting of mat willows, Dryas, Arctostaphylos, moss and lichen. Fertilizer effects on undisturbed alpine vegetation are visible in the background, to the right of the ROW.

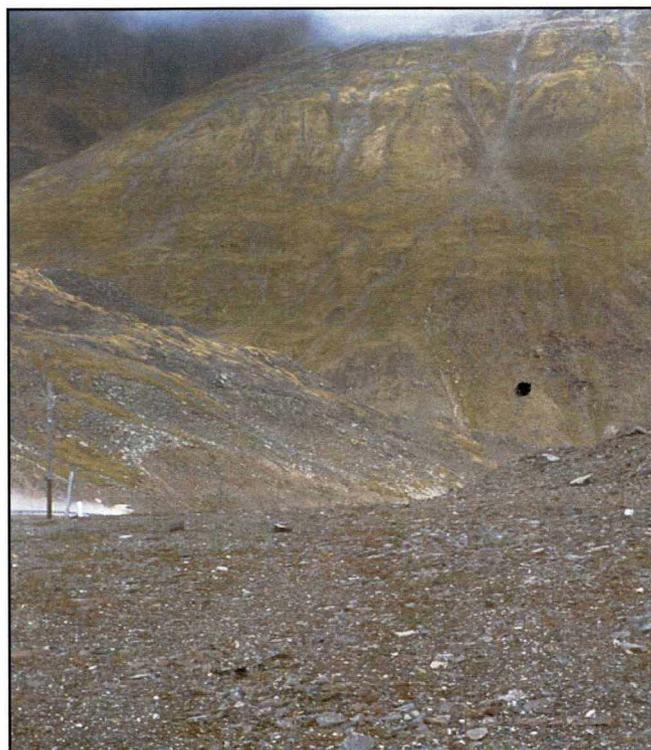
Photo 13-1. Northward over buried pipeline at the summit of Atigun Pass. Barren rock rubble predominates this site.

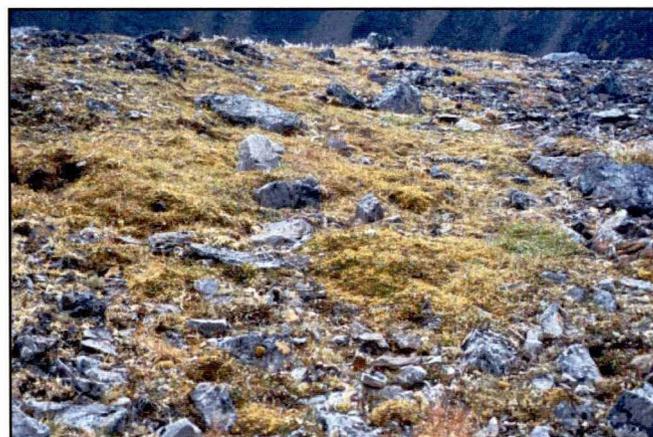
Photo 13-2. Alpine mat vegetation in the undisturbed habitat adjacent to the ROW. Moss and soil mineral fines provide a rooting substrate that supports higher plant life forms.

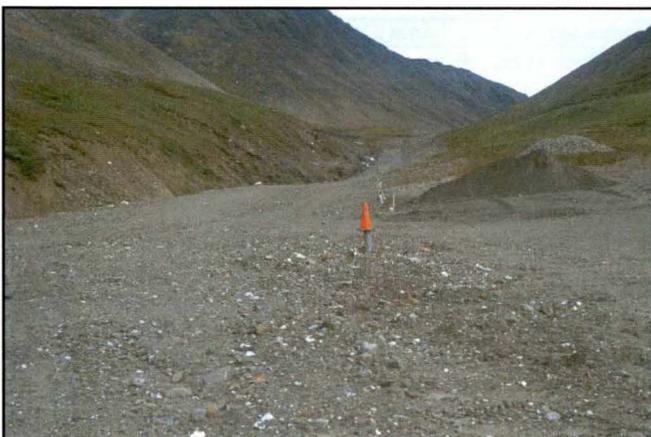
Photo 14-1. Barren gravel covers the buried pipeline on the south side of Atigun Pass. Recent maintenance activities on the pipeline at this location removed any plants that established following construction at this site.

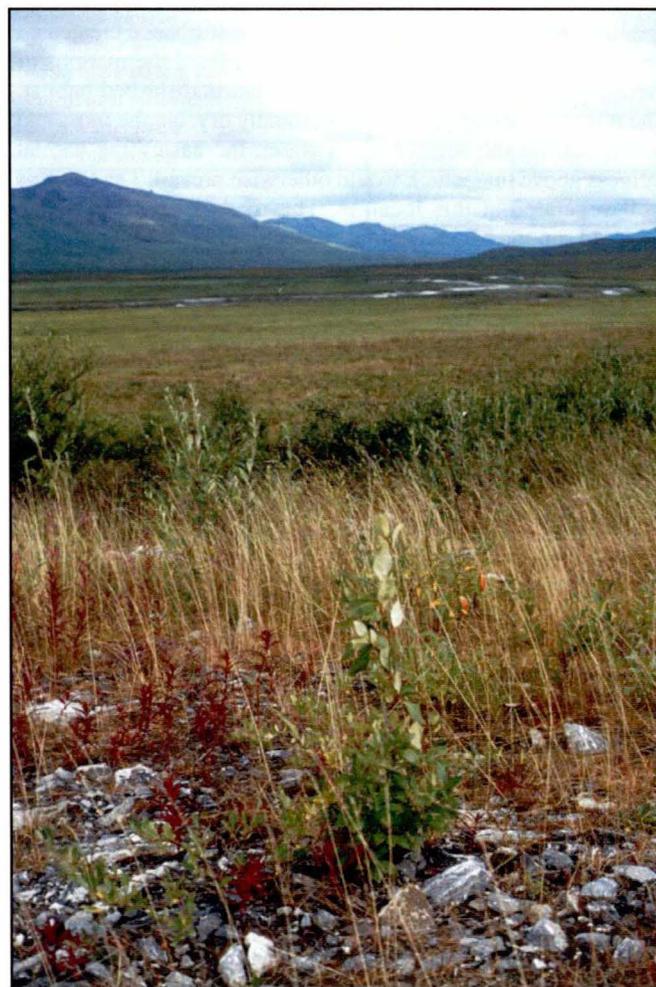
Photo 15-3. Cottonwood (*Populus balsamifera*) sapling on the Chandalar Shelf. This tree's natural geographical range was extended northward after construction of the pipeline opened new habitat.

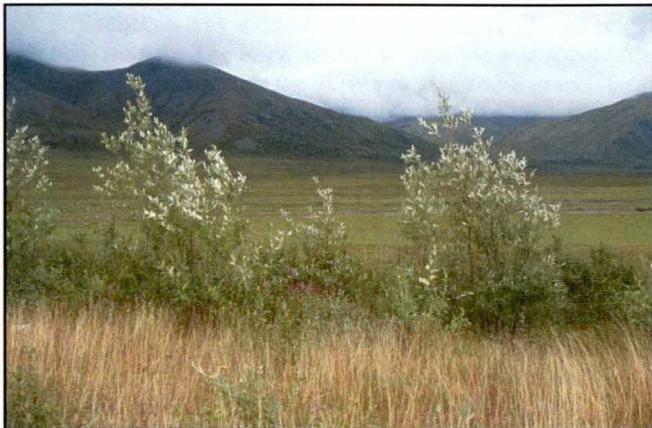
Photo 15-4. Tall willow on the edge of ROW gravel fill atop Chandalar Shelf. These plants attain much greater height in disturbed habitats than those in the adjacent undisturbed alpine community.

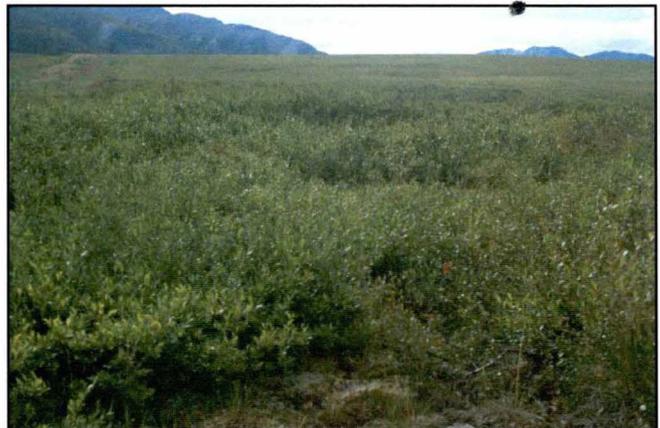
Photo 15-5. Willow, dwarf birch and dry lichen community adjacent to the ROW on Chandalar Shelf.

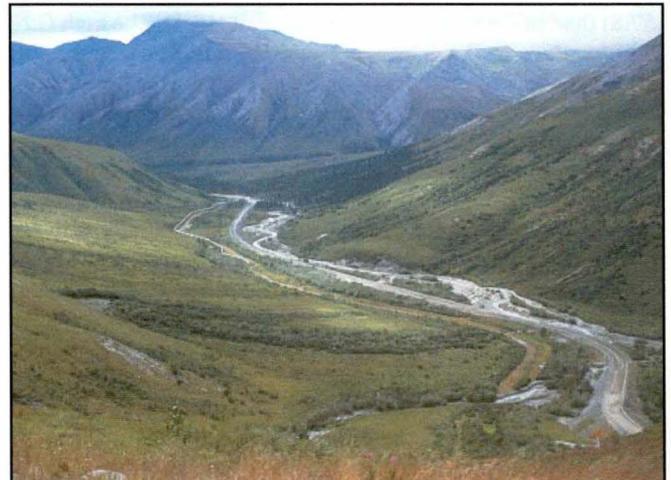
Photo 16-3. This site appears near the center of this photo taken from atop the Chandalar Shelf.

Site No. 16 is located below the Chandalar Shelf in the Dietrich River valley near treeline, the northernmost extension of forest. Treeline and timberline (elevational limits of forest) coincide here. This location is in glaciated terrain incised by fluvial erosion. Woody stumps within the ROW indicate this section of the corridor had been brushed in the past, but it had not been cut recently. Data were taken at one location, but we have photo records dating back to 1976 from farther south at the North Slope Borough boundary. Those images appear in the main portion of this document and illustrate colonization by alder on the winter haul road used to move equipment to Prudhoe Bay before the Dalton Highway was constructed. This location from the Chandalar shelf appears in Photo 16-3.

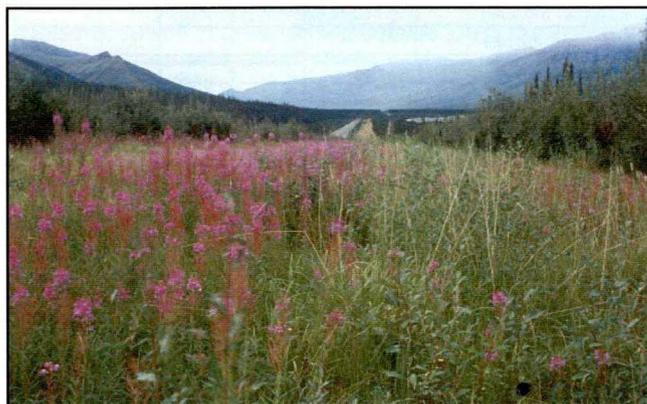
Photo 17-1. Northward view over buried pipe in Dietrich Valley. Fireweed (*Epilobium angustifolium*) and tall grasses dominate the central portion, most prominently over the buried pipeline. Willow are regrowing tall shrub canopies after being cut back as part of ROW maintenance.

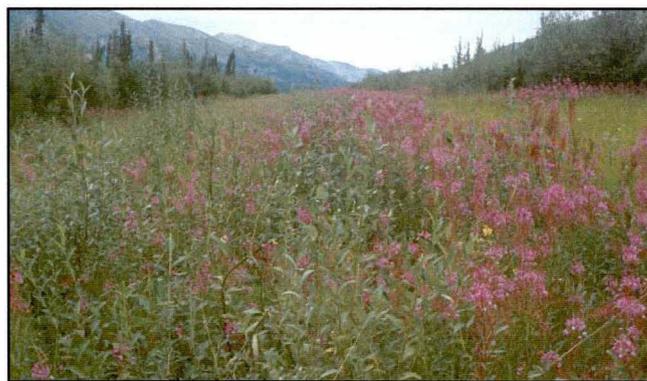
Photo 17-2. Southward view of ROW. Fireweed and meadow foxtail (*Alopecurus pratensis*) are most prominent in this photo.

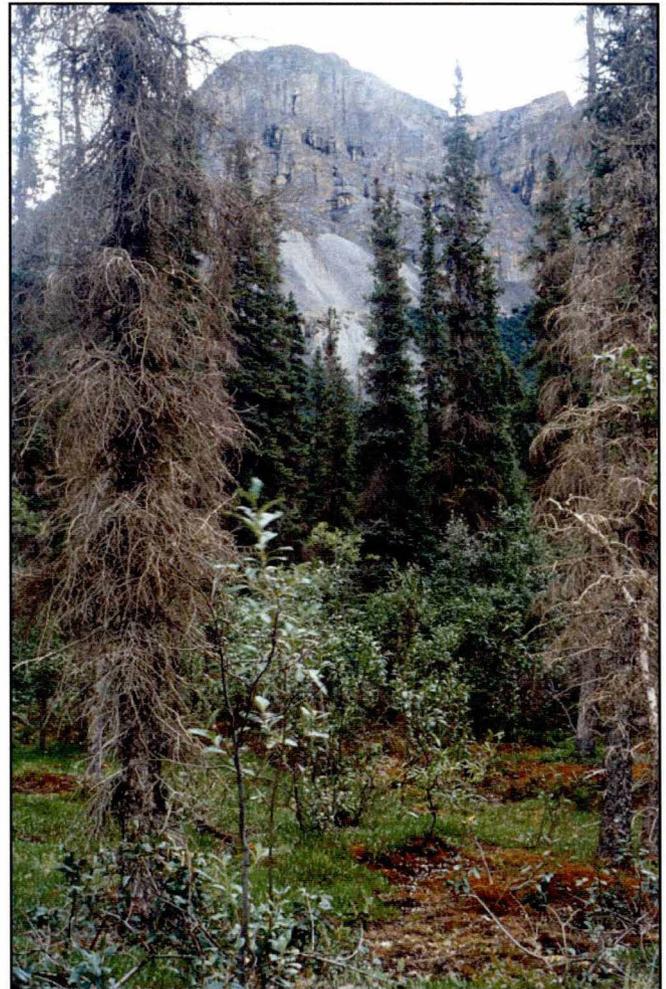
Photo 17-3. Spruce with an understory of willow and ground cover of *Dryas* occurs east of the Dalton Highway at this location.

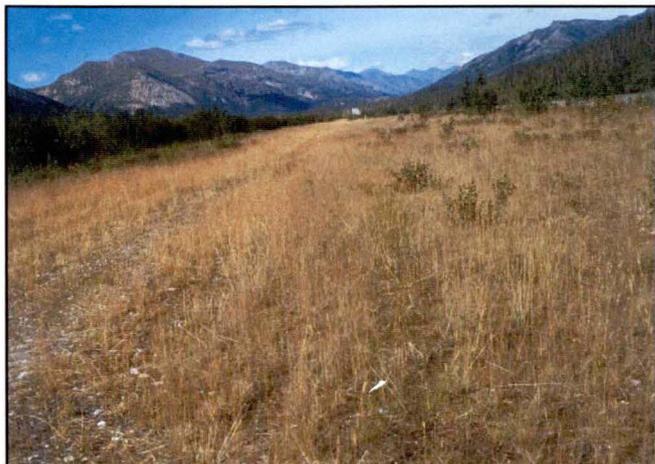
Photo 18-1. Northward view of buried pipe in Dietrich Valley. Seeded and natural grasses dominate this section of the ROW. Widely spaced shrubs and indigenous forbs have begun to invade.

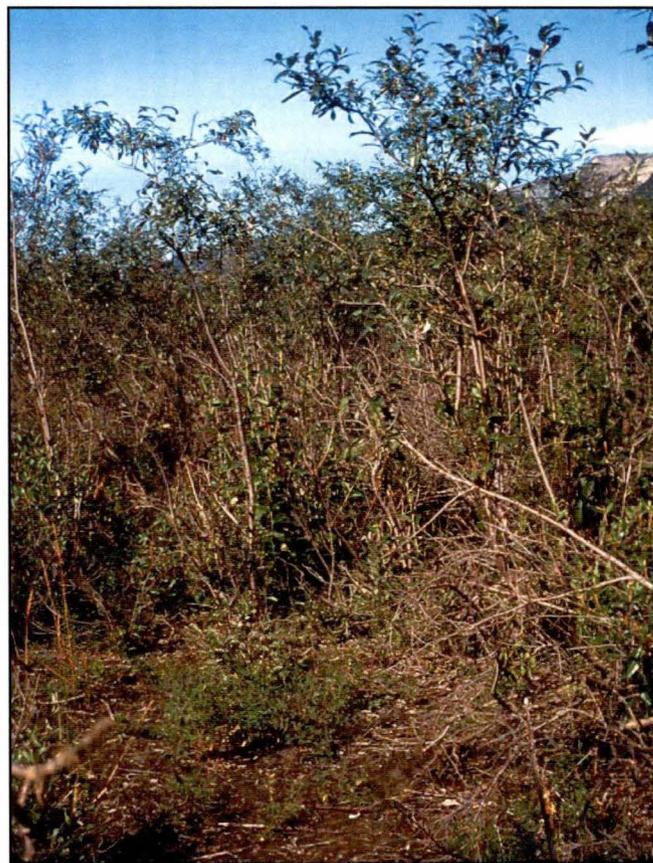
Photo 18-2. Fluvial gravel with a thin covering of silt in the adjacent habitat produces a shrub-dominated community.

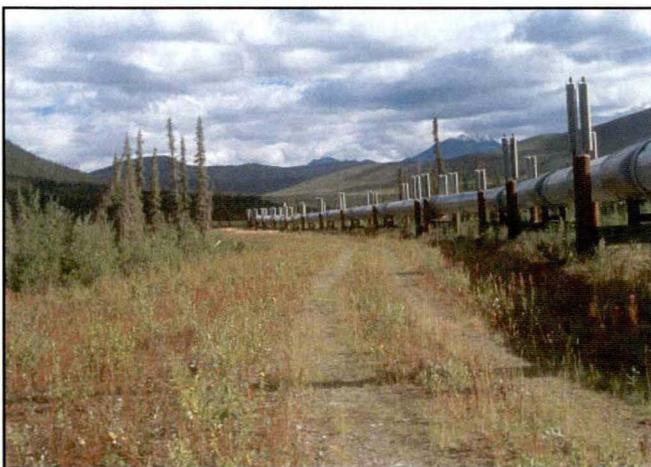
Photo 19.1 Shrubs predominate the natural vegetation of fill at this location. If not for periodic mowing, the entire ROW except for wheel tracks of the roadway would be covered with shrubs and trees. This is a southward view along elevated pipe.

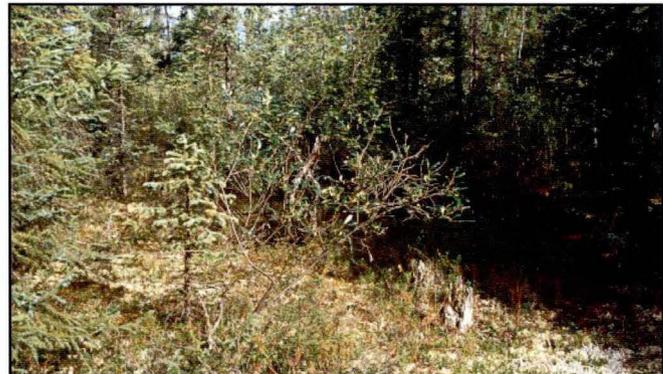
Photo 20-2. Adjacent vegetation is second growth black spruce, previously cutover in early mining days for wood to heat cabins and melt permafrost.

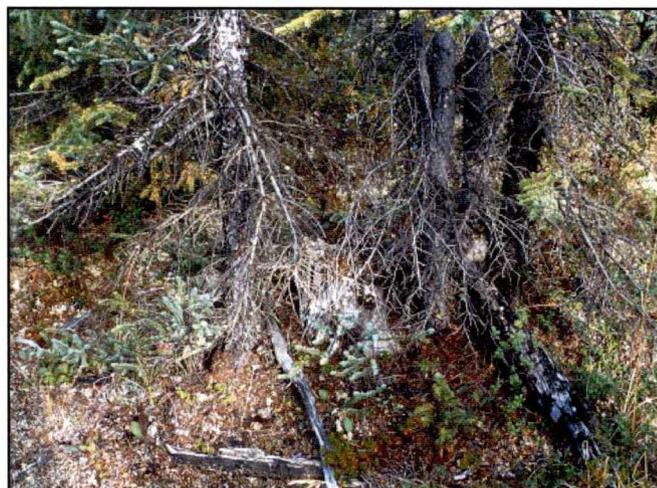
Photo 20-3. Decaying tree stump amid second growth black spruce. The remains of ax-cut trees are evidence of the presence of miners, trappers and settlers in the early 20<sup>th</sup> century in this part of Alaska.

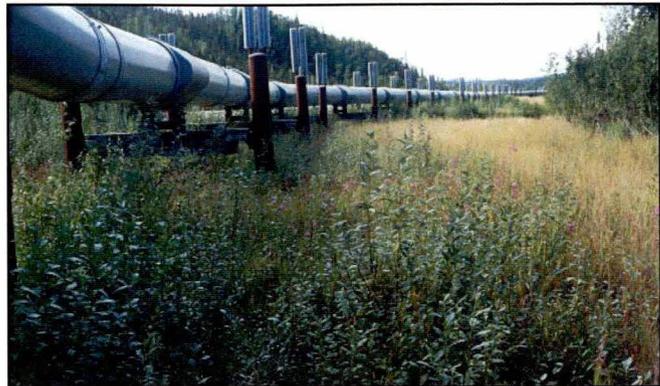
Photo 21-1. Southward view along elevated pipeline. This portion of the ROW is becoming overgrown with shrubs and is probably a candidate for brush removal. The gravel roadway is well-vegetated by grasses.

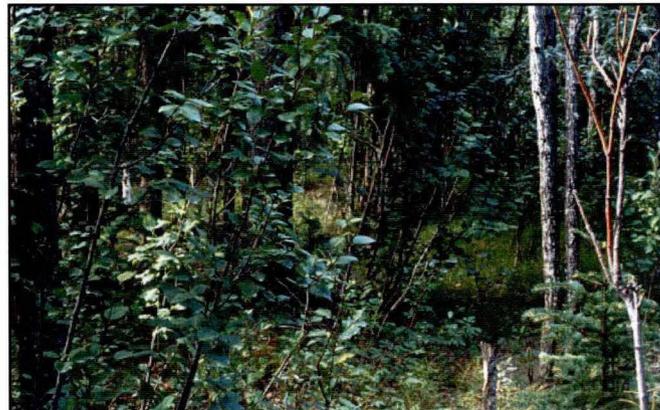
Photo 21-2. The adjacent forest has a prominent understory of tall shrubs (willow and alder).

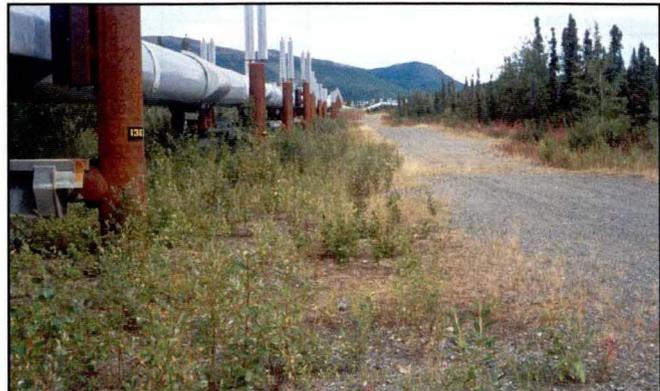
Photo 22-1. Northward along elevated pipeline. Cottonwood and willow are common invaders of this portion of the ROW. The gravel roadway is largely barren with a fringe of grasses along the margins of wheel tracks.

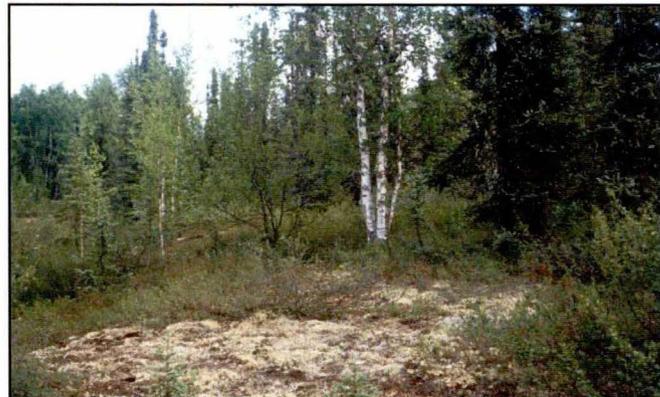
Photo 22-2. Open mixed forest with shrubs and thick patches of lichen occur in the undisturbed habitat at this location.

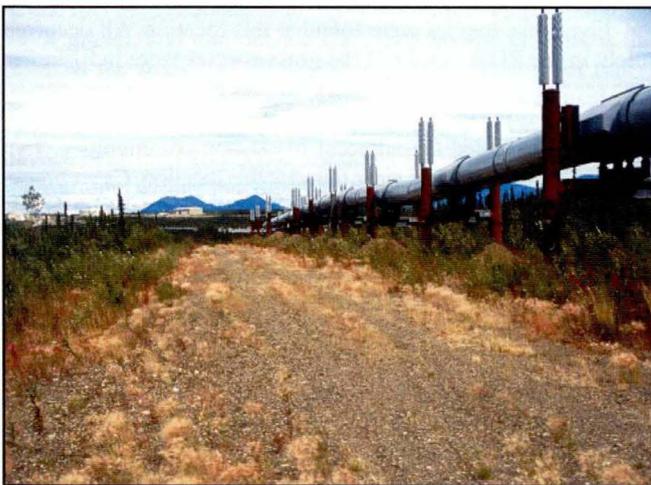
Photo 23-1. Pump Station 5 is visible in the background of this northward view along an elevated section of pipe. Beneath the pipe, gravel fill has been invaded largely with shrubs. The grass *Hordeum jubatum* lines the wheel tracks of the roadway. Fresh heaps of fill are visible between pipeline VSMs. This fill is being used to bring depressions to grade. Frost bulbs have formed and lifted the soil, leaving low spots between VSMs.

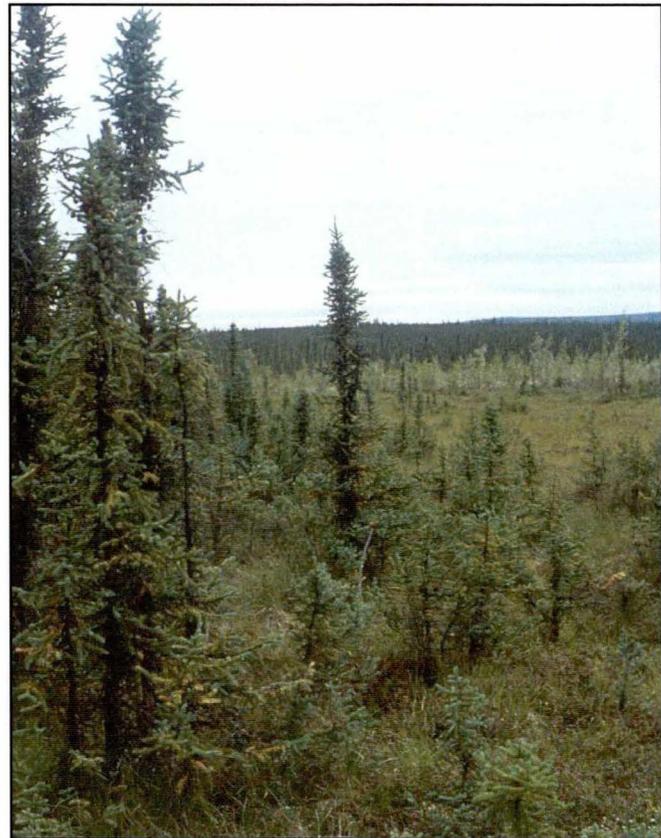
Photo 23-2. The adjacent habitat is a matrix of bog and black spruce, with the spruce occurring on higher ground. Soil samples were difficult to obtain on 29 July 1999 since the ground was frozen just beneath the organic mat.
