# Soils and Vegetation of the Trans-Alaska Pipeline Route: A 1999 Survey

Bulletin 109

January 2002

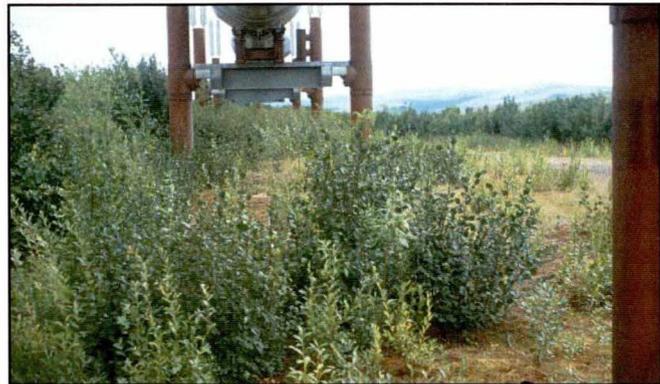
Photo 24-1. Southward view under elevated pipeline. Alder and willow shrubs are actively invading fill beneath the pipeline, and moss covers the soil surface. Wheel tracks in the roadway are barren gravel, and grasses line the road.

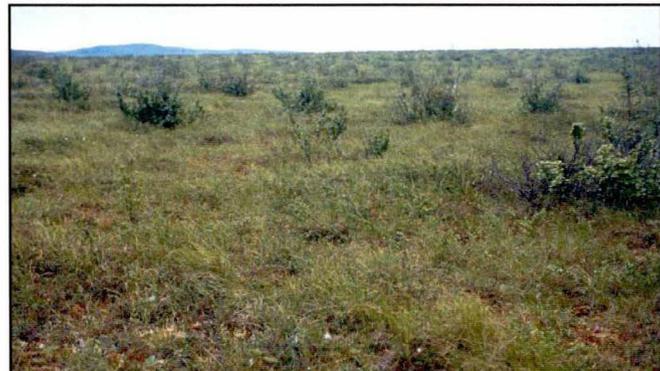
Photo 24-2. Alpine tussock shrub tundra occupies the adjacent habitat. A scattering of alder and spruce occur in this vegetation type.

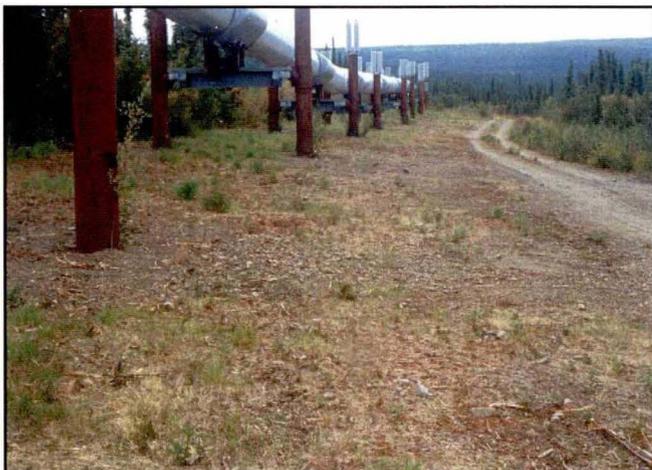
Photo 25-1. Northward view along section of elevated pipeline. Brush and young trees have recently been cut from beneath the pipe, leaving stumps and wood debris on the soil surface. Short grasses and uncut shrubs line the outer margin of the roadway. Wheel tracks are barren.

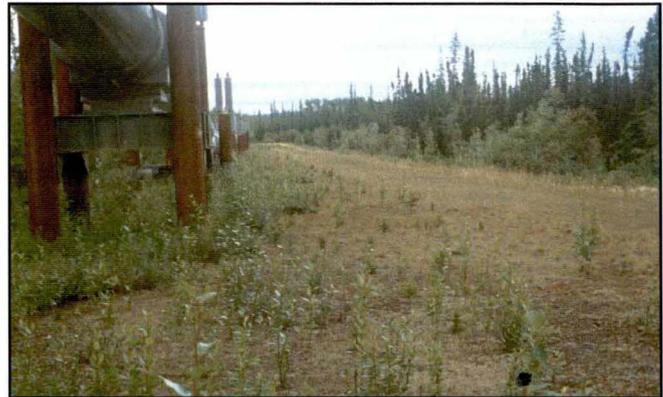
Photo 26-1. Vegetation under the pipeline includes naturally colonized lichens, shrubs and trees. Grasses appear in the roadway. Next to the forest, the ROW outer margin supports tall shrubs that have not been cut.

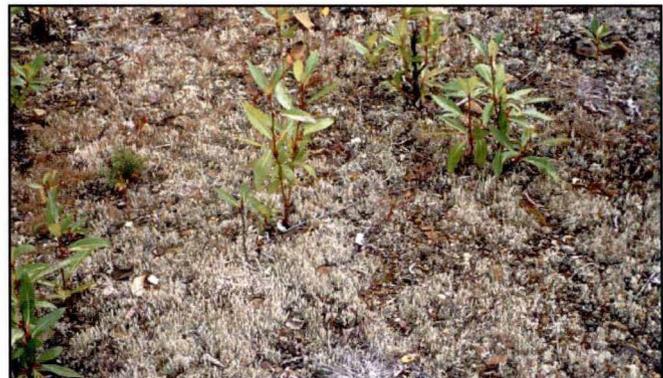
Photo 26-2. Dense lichen cover has formed on the surface of the fill under the pipeline. Cottonwood and spruce have established. The young trees in this photo appear to have been cut at least once.

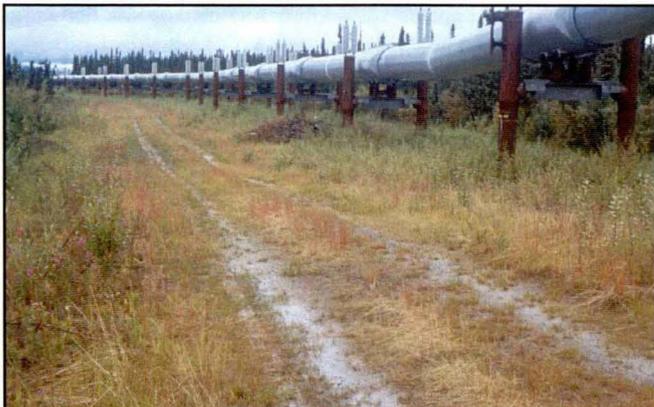
Photo 27-1. The ROW at this site is covered with vegetation, except for wheel tracks. The area beneath the pipe and next to the road are becoming overgrown with shrubs and small trees. These woody plants appeared to have been cut in prior years. Grasses dominate next to and between wheel tracks.

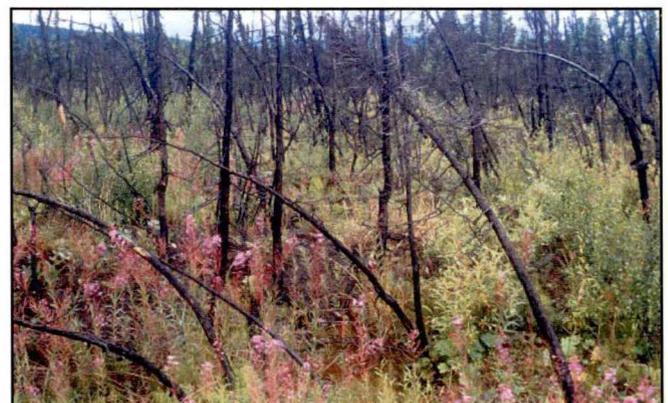
Photo 27-3. On the west side of the ROW, a wildfire destroyed the forest. Fireweed, forbs and sprouting shrubs have begun to occupy this burned area.

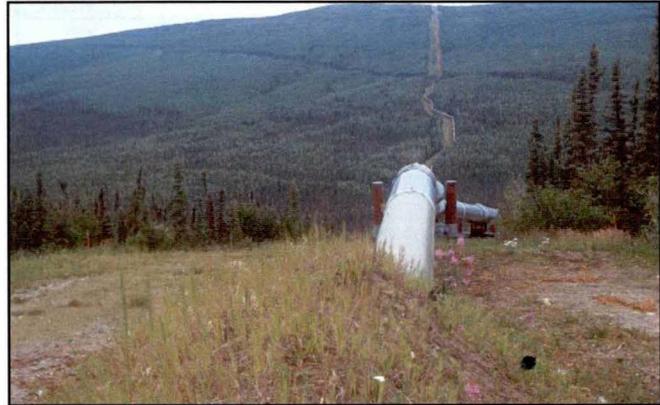
Photo 28-1. Northward view of elevated pipeline as it goes underground. Brushing has kept the ROW free of trees and shrubs. Seeded *Bromus inermis* occupies the mound of soil over the buried pipe.

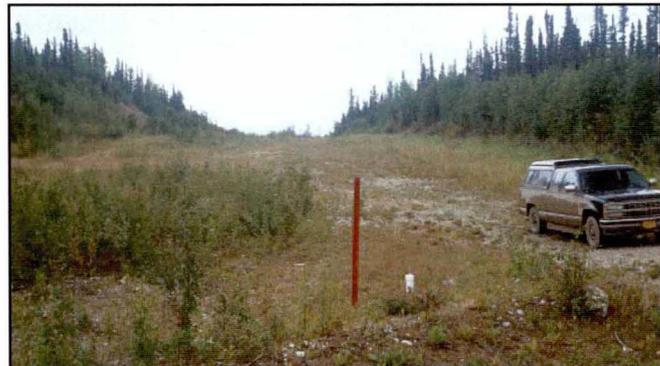
Photo 28-2. Looking southward, the pipeline is buried. The ROW lies in a cut vegetated with alder and other shrubs. The central portion supports mostly grasses and has been brushed to remove invading trees and shrubs.

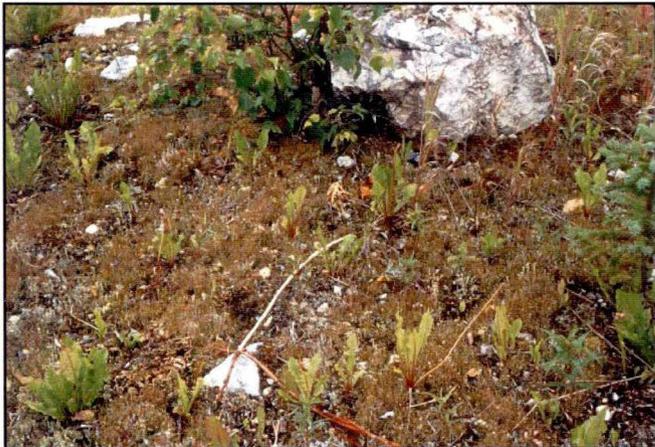
Photo 28-3. In a portion of the ROW not disturbed by traffic and brush cutting machinery, a dense mat of lichens has formed on the soil surface. Dandelion, an introduced weed, grows among the lichens. Paper birch and white spruce seedlings are in this image.

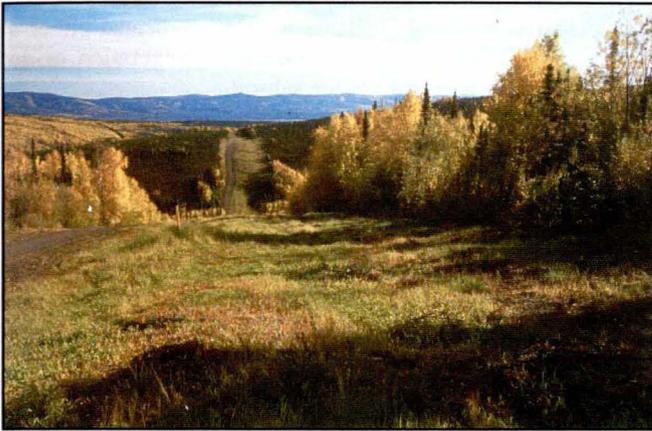
Photo 29-1. Southward view of buried section of pipeline. The ROW in this location is heavily invaded by shrubs and trees. This section was recently brushed to control these woody species, which will allow grasses and herbs to predominate for a short time. The roadway is largely barren gravel. Water bars to control runoff are evident on the distant slope.

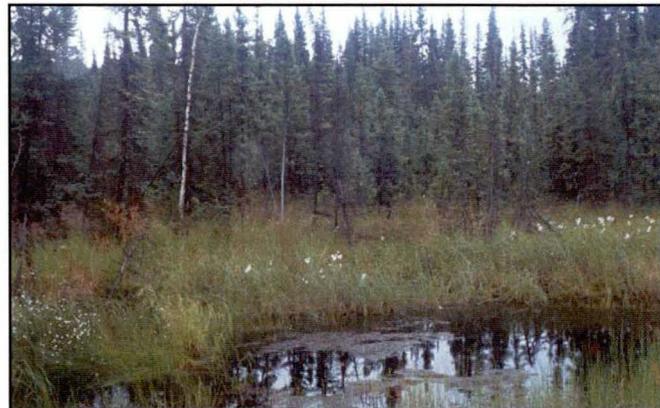
Photo 30-2. Adjacent to the ROW, a floating bog of black spruce partially covers a pond.

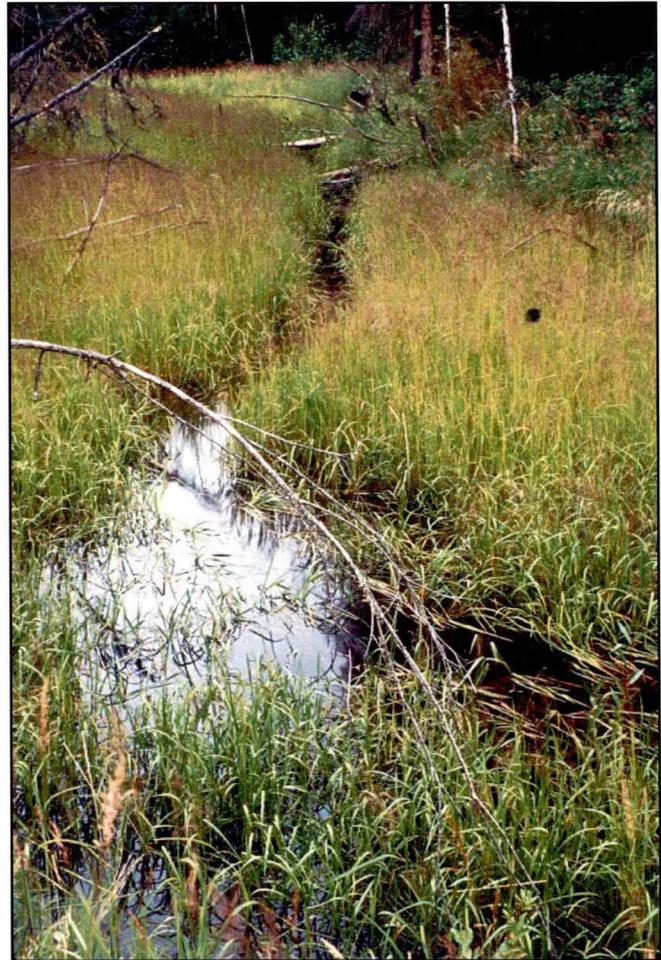
Photo 30-3. A stream lined with *Arctophila fulva* plants flows across the ROW route.

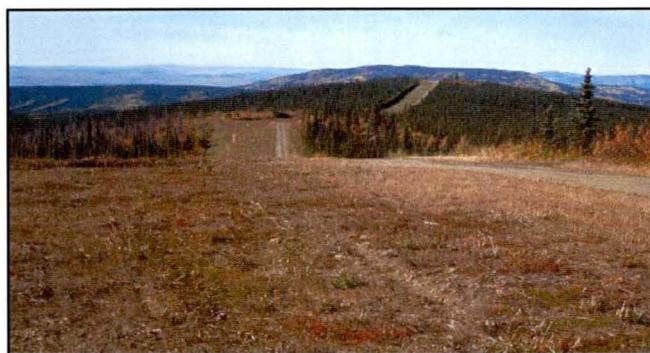
Photo 31-1. Northward view of the buried pipeline shows recent brushing to remove the overtaking shrub and tree cover. The entire ROW has been cut. Usually the outer margin beyond the roadway is not cut.

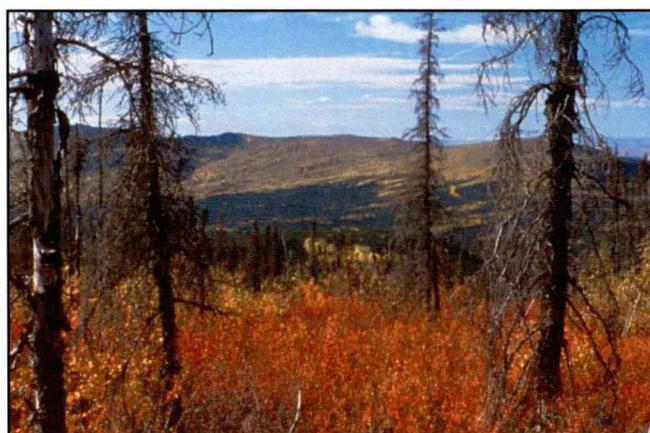
Photo 31-2. West of the pipeline a wildfire destroyed the natural spruce forest. This burnt habitat is currently dominated by shrub birch, whose leaves have turned red in this September photo.

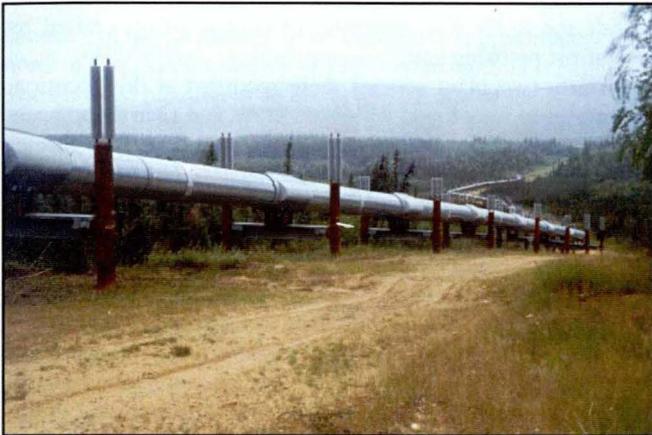
Photo 32-1. Northward view of elevated section of pipeline. The ROW at this location is largely invaded with shrubs and trees. Recent brushing to control that woody growth allows herbaceous plants, grasses and forbs to temporarily predominate. However, the stumps are sprouting, and soon the canopy beneath the pipe will consist of woody plants. Grasses dominate along the margins of the roadway.

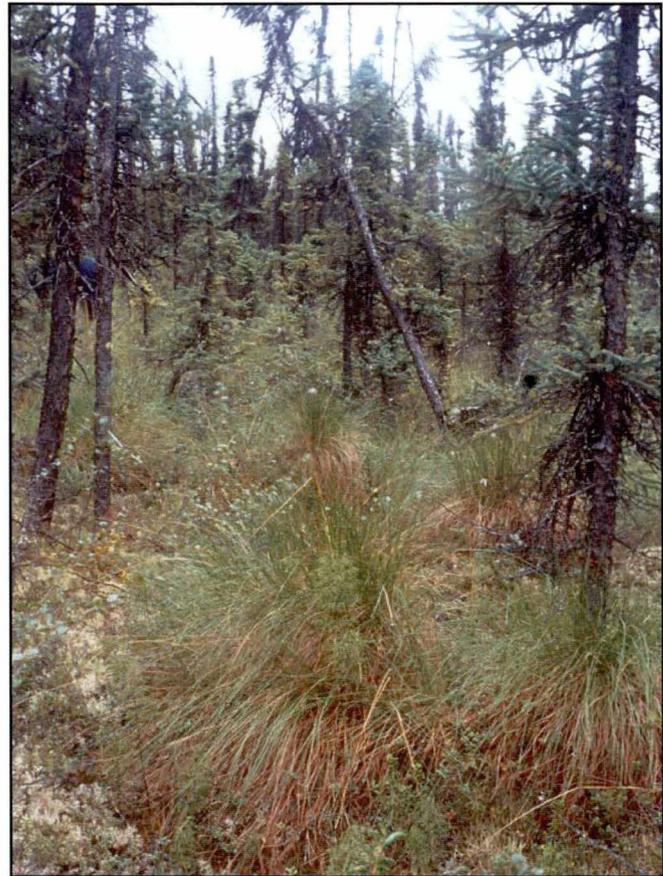
Photo 32-2. The adjacent forest is black spruce on this north-facing slope. Large clumps of tufted cottongrass (*Eriophorum vaginatum*) appear among the trees.

One sedge species (*Eriophorum vaginatum*) was a prominent forest floor herb at this location. This indigenous cottongrass is common in black spruce forests and its hummocks are the primary component of tussock tundra. Tussock sizes at this site were among the largest found during our survey (see Site #36). No sedges occurred in the ROW at this location. Presumably, competition and perhaps drier soil hydrology of the ROW were responsible for the absence of sedges in the disturbed habitat.

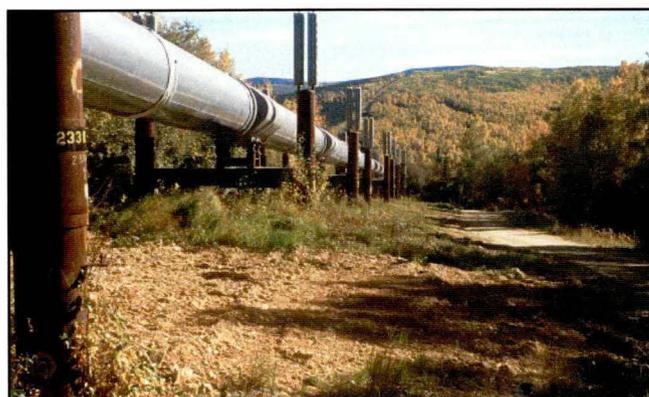
Photo 33-1. Eastward view along elevated section of pipeline. The ROW beneath the pipe has been largely invaded by trees and shrubs, which have been cut to control the growth. The roadway is largely barren. Fill has been placed between VSMs after frost bulbs raised the soil surface.

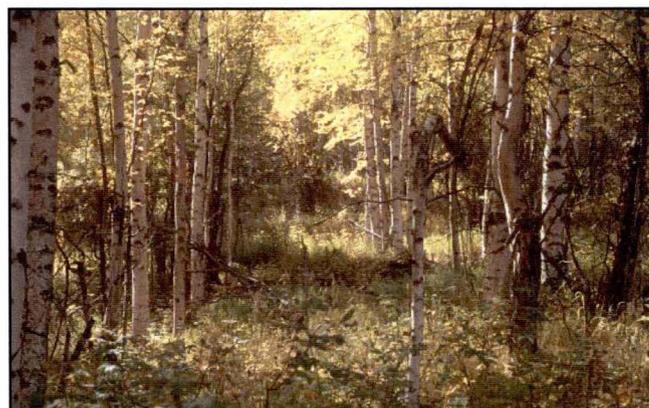
Photo 33-2. The natural vegetation on this south-facing slope is a paper birch forest with an understory of rose (*Rosa acicularis*).

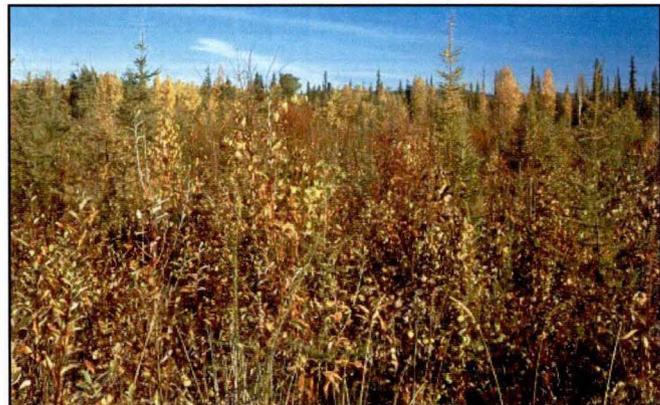
Photo 34-2. Vegetation to the north of the ROW is a cleared forest that is recolonizing through natural processes, and currently is dominated by shrubs and tree saplings.

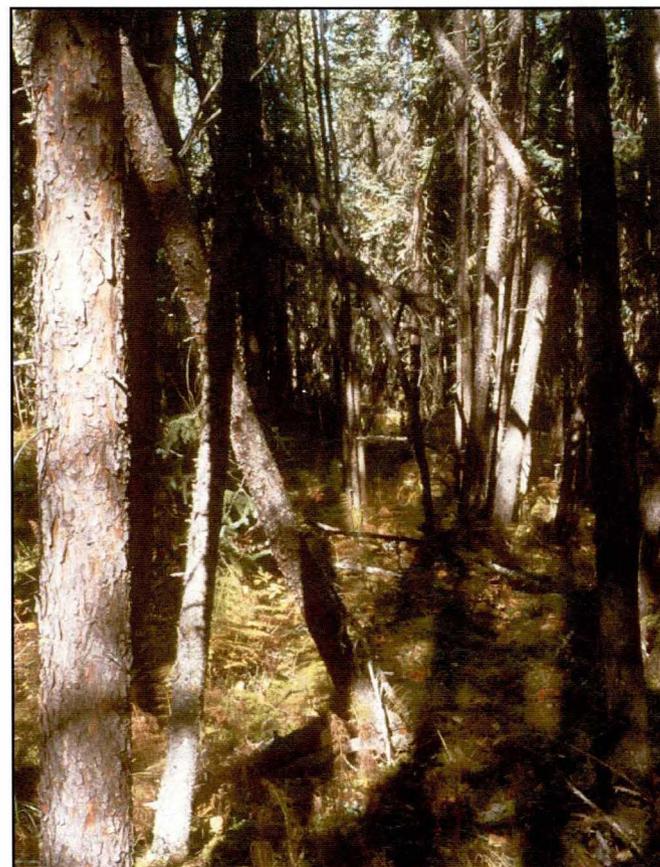
Photo 35-2. Northward view in the dense spruce forest west of the pipeline. The forest floor at this location is carpeted with moss.

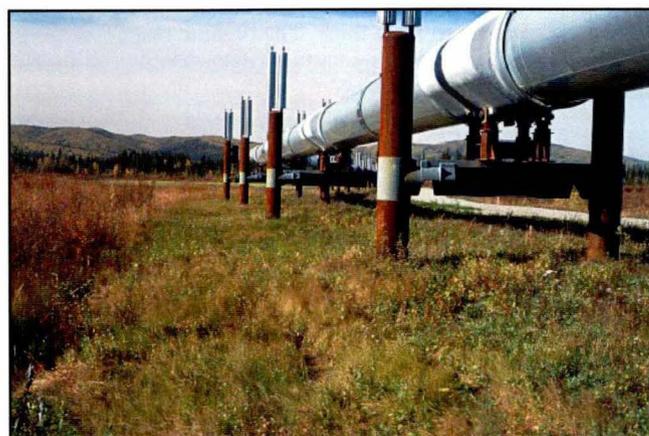
Photo 36-1. Northward view along elevated section of pipeline. Seeded grasses and indigenous shrubs provide a complete cover beneath the pipeline. This portion has been brushed to control woody plants.

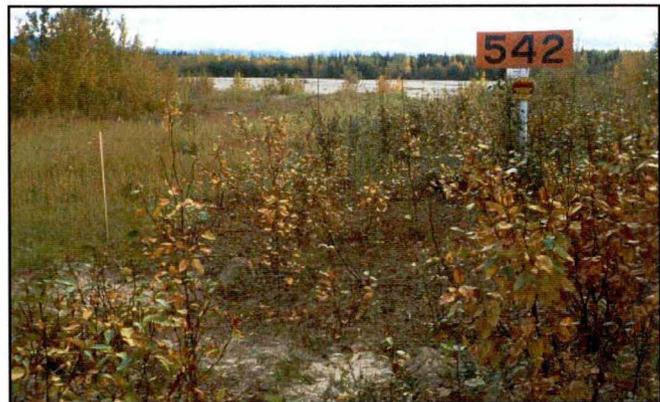
Photo 37-1. Southward across buried pipeline on the outskirts of Delta Junction. Sandy soil was deposited from nearby Jarvis Creek. Cottonwood dominates a portion of the ROW, and seeded grasses elsewhere.

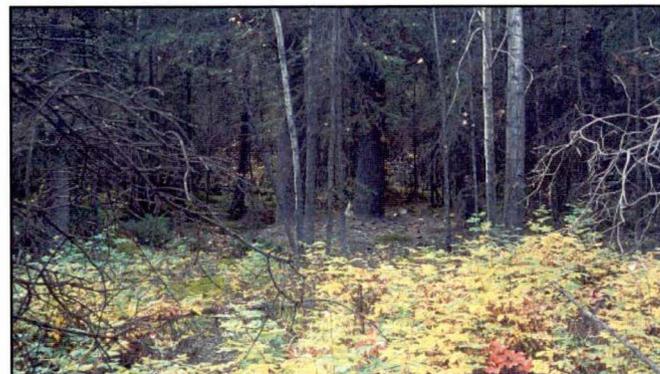
Photo 37-2. The adjacent spruce/cottonwood forest has an understory of rose (*Rosa acicularis*). The forest floor is largely barren sand with a thin cover of plant debris.

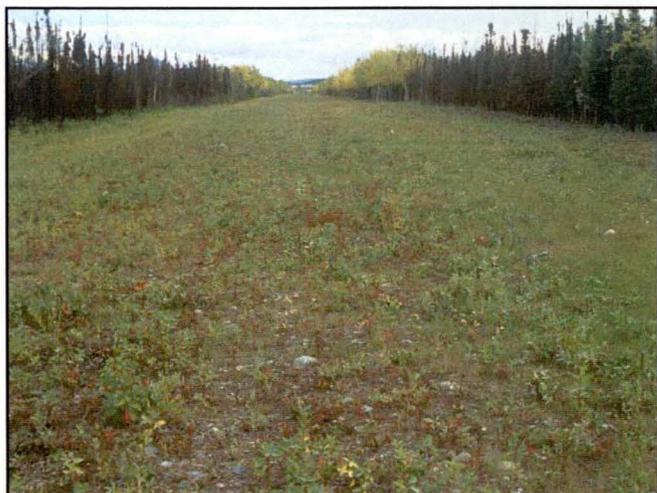
Photo 38-1. Southward view toward Pump Station 9. The pipeline is buried, and a mixture of seeded and natural plant species has overgrown the entire ROW, which was recently mowed to control woody plants.

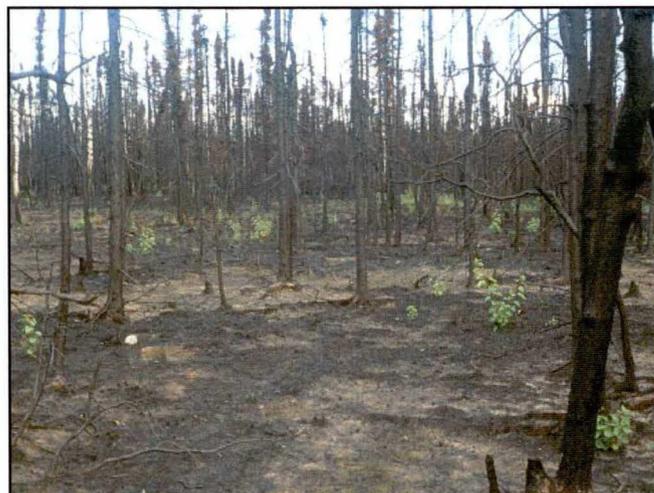
Photo 38-2. A wildfire burned the spruce/aspen forest on the east side of the ROW earlier in the 1999 season. By September, stump sprouting and regrowth of grass and forbs had commenced.

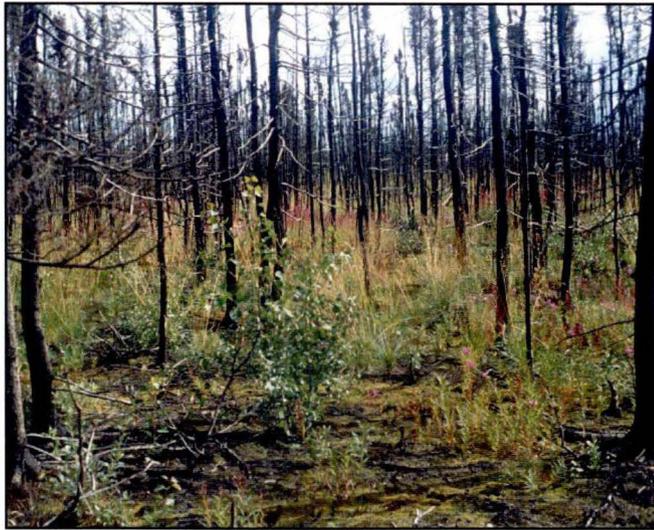
Photo 38-3. View of the burned forest shown in Photo 38-2 after two growing seasons. Notice the regeneration of forest-floor plants, including stump sprouts of deciduous tree species. A number of the herbaceous plants were absent in the unburned community.

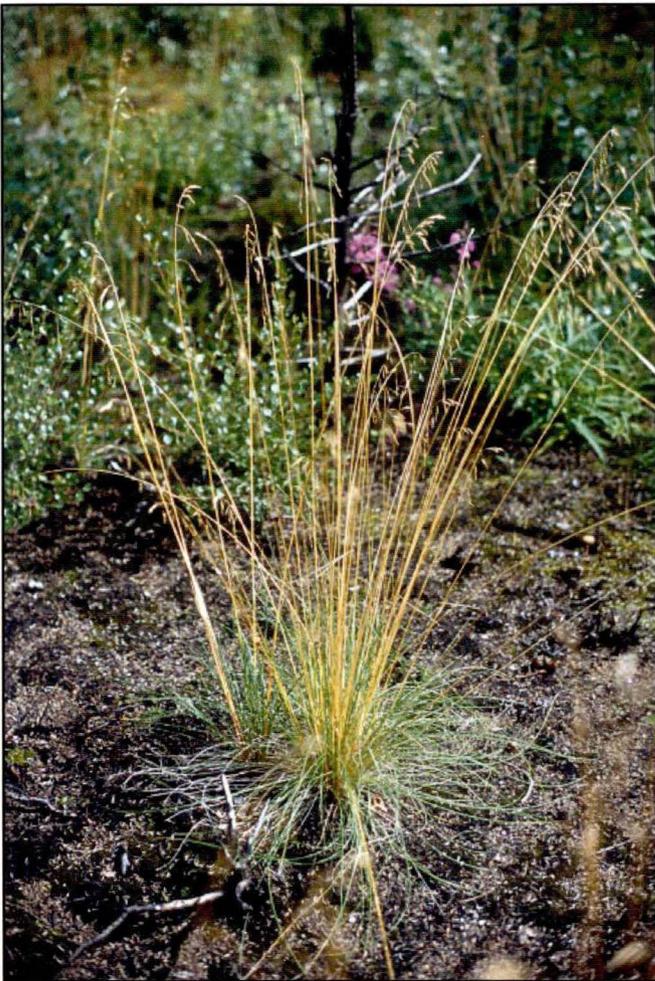
Photo 38-4. A vigorous *Festuca altaica* plant growing within an area of black spruce forest burned in two years prior. This indigenous bunchgrass was found colonizing portions of the TAPS ROW and was often present in the adjacent undisturbed communities along the pipeline route.

specimens in the burned area (Photo 38-4). No grass species was common to both habitats. *Agropyron* spp. is an indigenous grass that invaded this site through natural means. *F. rubra* is an indigenous grass but was introduced during ROW revegetation.

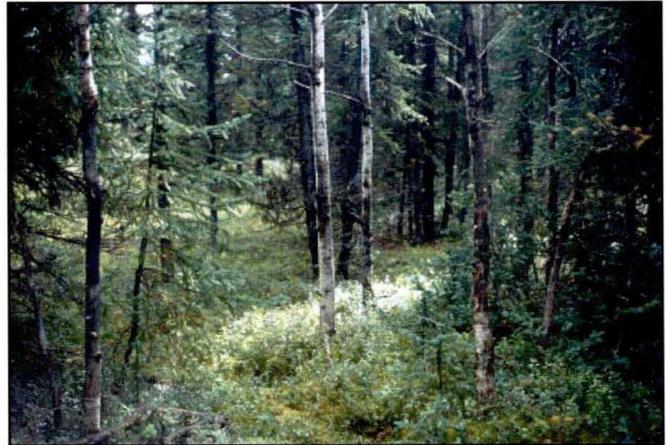
Photo 38-5. West of the pipeline there is a mixed forest that escaped the fire. The forest floor is carpeted with moss and produces a few heath shrubs.

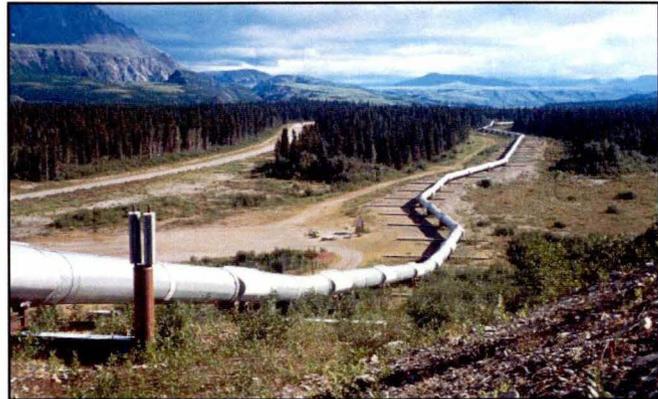
Photo 40-1. Southward view of pipeline at the Denali Fault. Gravel fill at this location is poorly vegetated, supporting only a few grasses. Wheel tracks are barren in the well-used roadway. Shrubs and trees have invaded portions of the ROW without traffic and gravel fill. Mowing is probably used to control these woody plants.

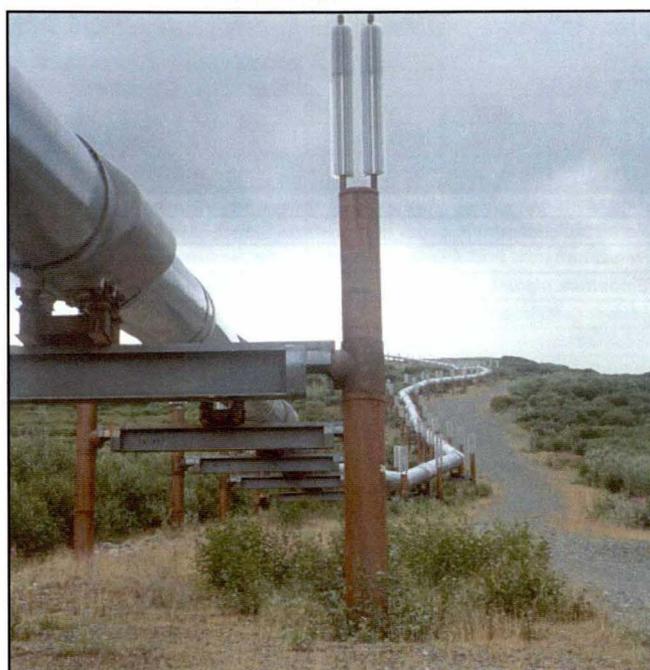
Photo 41-1. Northwest view up slope above Phelan Creek. Seeded fescue grass and indigenous shrubs appear in the ROW.

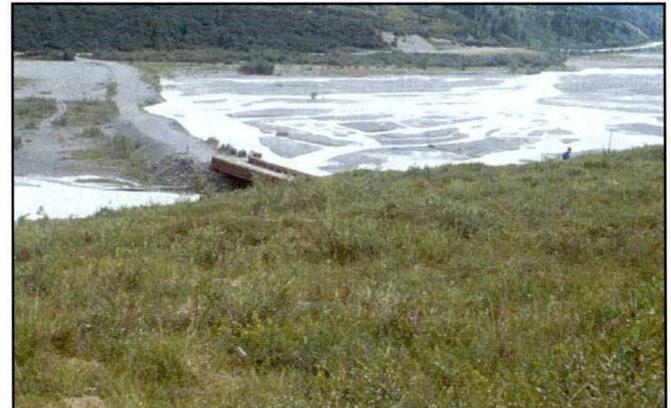
Photo 41-2. Undisturbed vegetation adjacent to the ROW is alpine shrub/sedge with incursions of tall shrubs and occasional spruce.

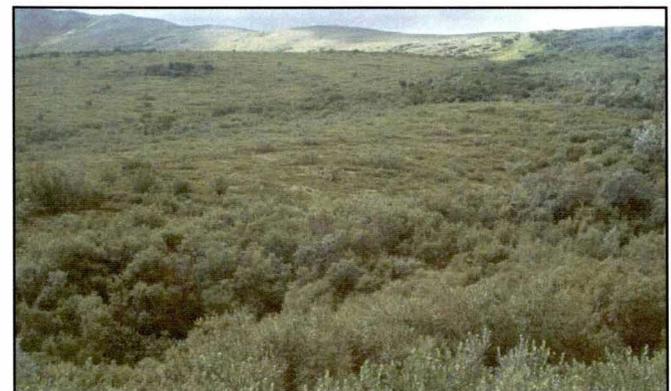
Photo 41-3. West of the pipeline, a mixture of low shrub and tall shrub alpine vegetation covers the slope.

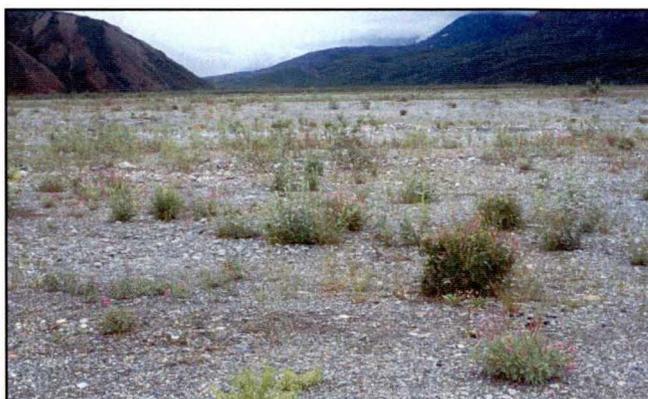
Photo 42-1. Naturally colonizing forbs, shrubs and a few grasses on gravel outwash at the Isabel construction camp site. Although the site was seeded and fertilized, no evidence of revegetation was found.

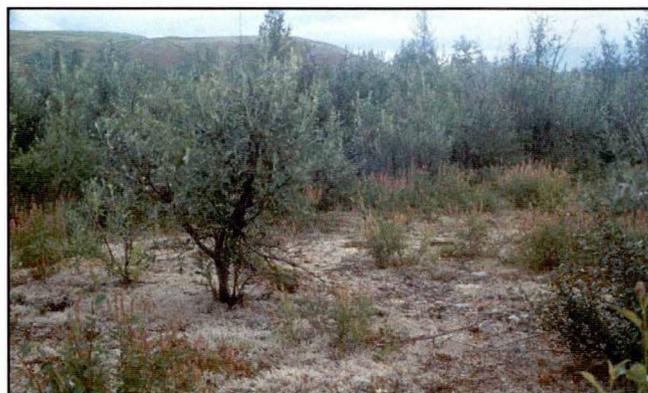
Photo 42-2. South of the camp site, a complex of tall willow, cottonwood, herb and lichen vegetation covered the gravel.

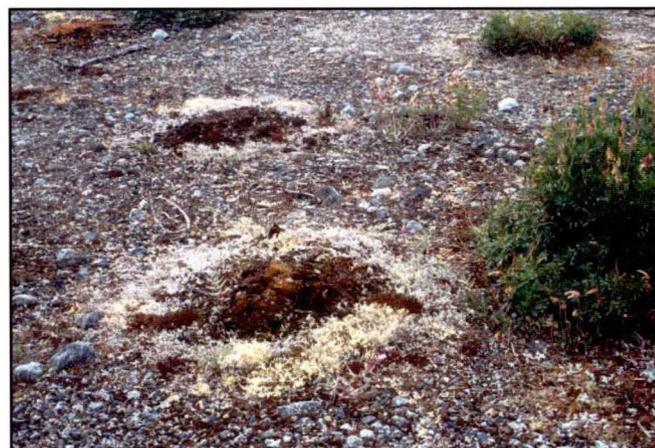
Photo 42-3. Pioneering *Hedysarum mackenzii* and *H. alpinum* establish on open gravel. These plants trap soil fines carried in by the wind. Mosses and lichens establish around the plants and continue to accumulate fines, adding organic matter to the soil. Eventually the herb dies, leaving a ring of decayed moss and lichen on the gravel surface as in this image.

the legume plant dies, leaving a dark center (partially decomposed organic matter) ringed with a light-colored lichen community. Our observations were time-constrained at this site, but it was clear that interesting ecological processes related to soil and plant community development were occurring at this location. This site demonstrates the importance of N-fixing plant species for vegetating open gravel.

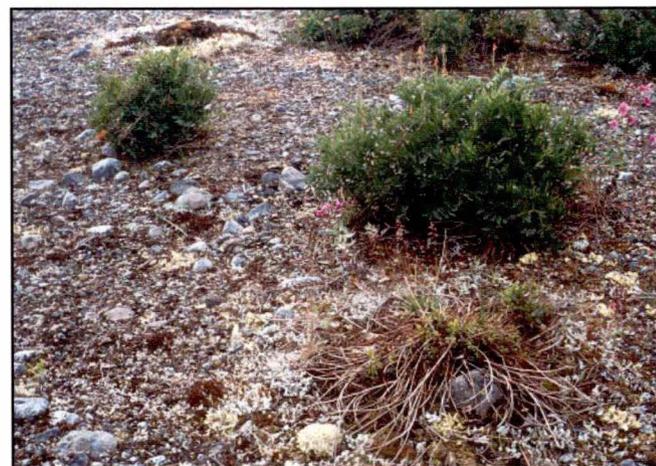
Photo 42-4. Living and dead *Hedysarum mackenzii* plants.

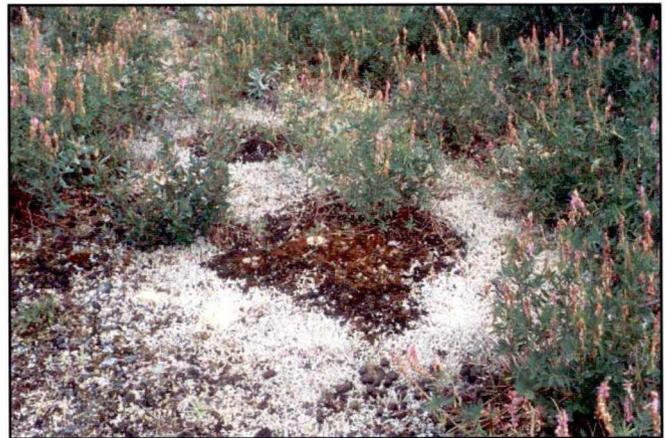
Photo 42-5. *H. alpinum* surrounded by *Stereocaulon* and other lichen. Buffalo berry, *Shepherdia canadensis*, can be seen in the upper left center of this photo. Buffalo berry is a pioneer that probably fixes atmospheric N.

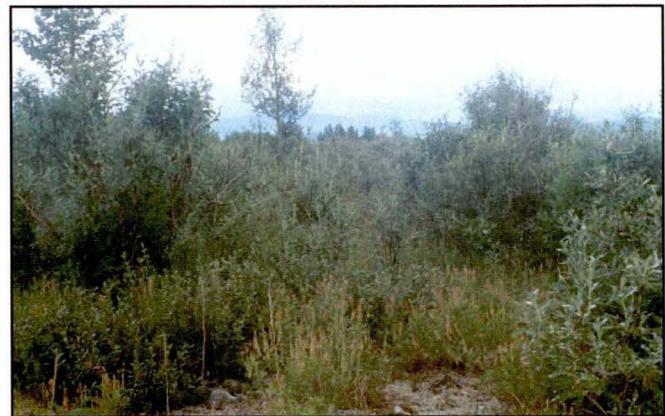
Photo 42-6. General view of trees, shrubs, and forbs established on glacial outwash.

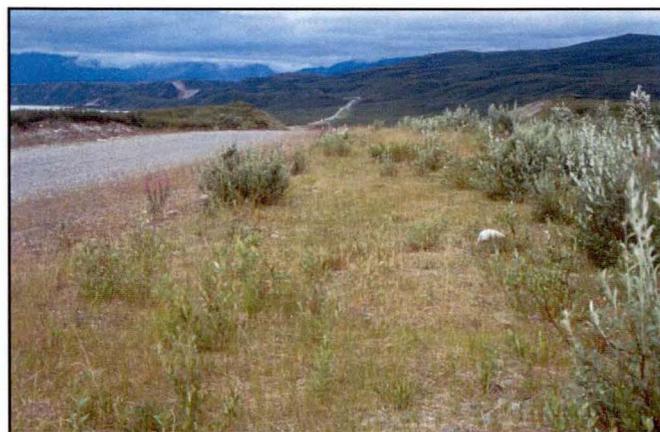
Photo 43-1. Northward view of buried pipeline near Summit Lake. The ROW is mostly vegetated with seeded fescue grass. The roadway is barren gravel. Shrubs are invading over the buried pipeline and outside the roadway.

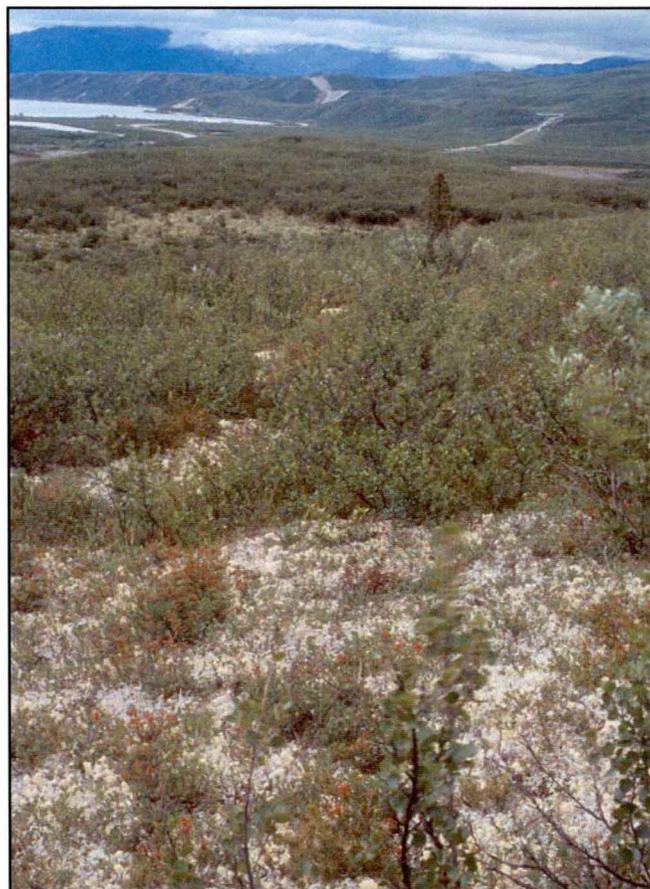
Photo 43-2. Adjacent vegetation is open shrub with lichen and heath species covering the ground. A few spruce trees appear on the landscape.

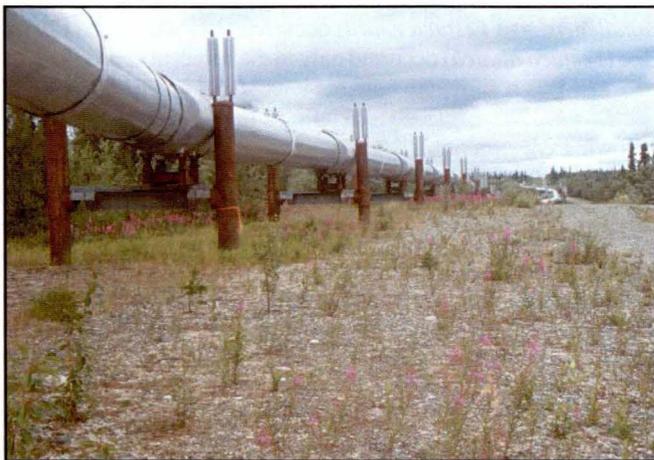
Photo 44-1. Gravel fill in this location is being invaded by shrubs and trees, except in the roadway, which remains barren gravel. Fireweed, horsetail and a few grasses predominate among the shrubs and trees.

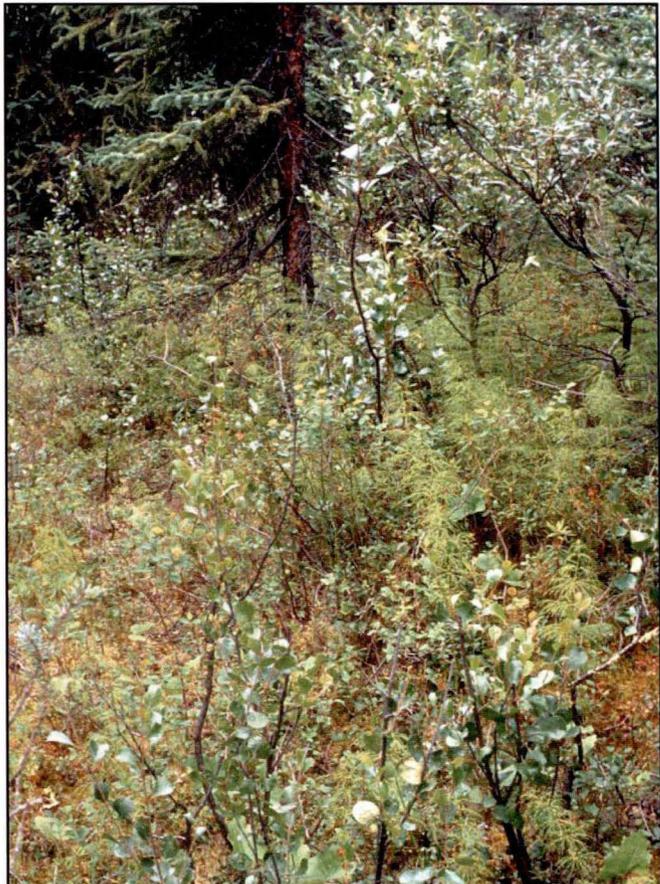
Photo 44-2. Adjacent vegetation is a spruce forest with willow, shrub birch, and horsetail in the understory. The soil surface is carpeted with lichens and mosses.

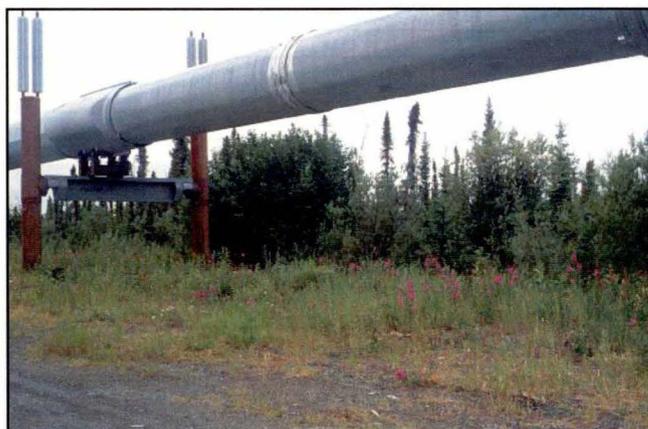
Photo 45-1. Shrubs, forbs and grasses have established beneath the elevated pipeline at this location. Brushing is probably used to control the woody plant growth.

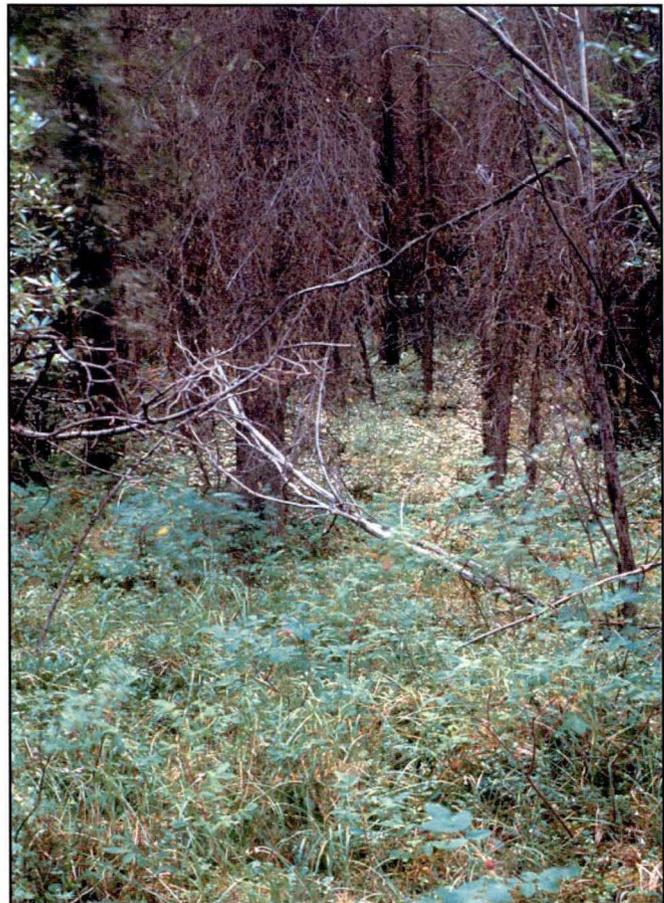
Photo 46-2. The adjacent spruce forest has an understory dominated by rose shrubs.

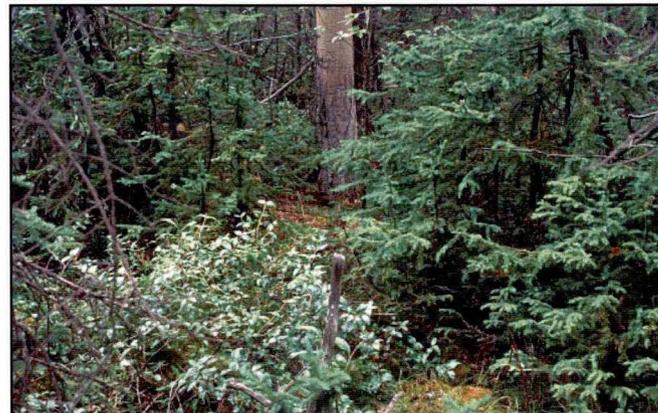
Photo 47-2. Second growth mixed forest adjacent to the ROW.

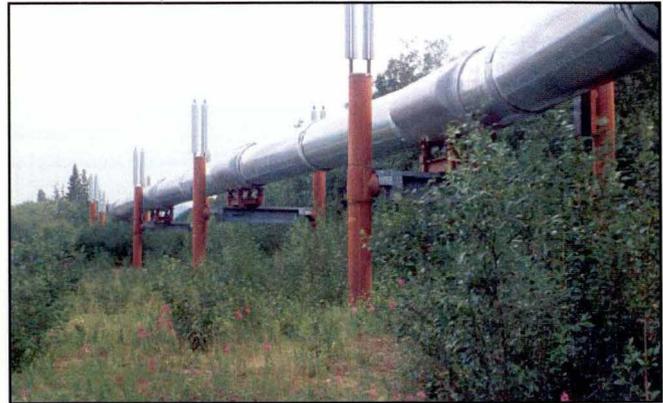
Photo 48-1. Northward view along elevated pipeline. Naturally established tall shrubs and forbs dominate the ROW. This section has not been brushed recently.

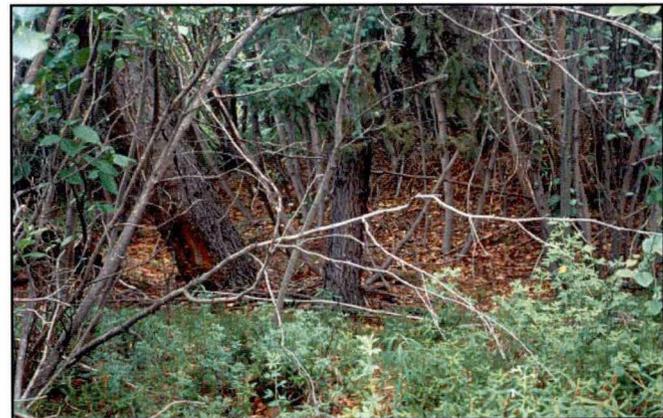
Photo 48-2. Second growth mixed forest east of the ROW.

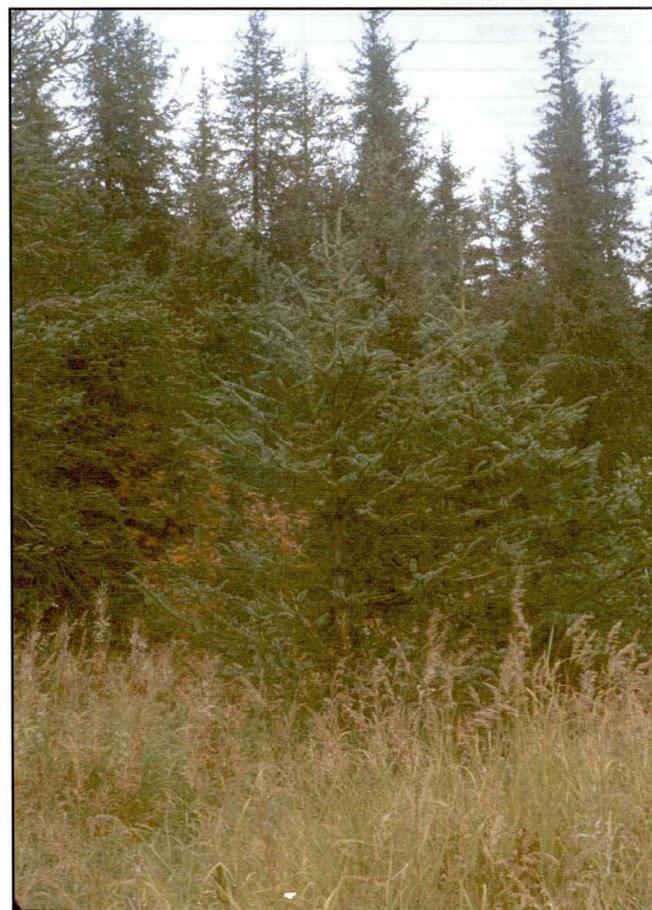
Photo 52-2. View of the coastal spruce forest south of the ROW.
